## Building & Pest Inspection Report

Building & Pest Inspection Report

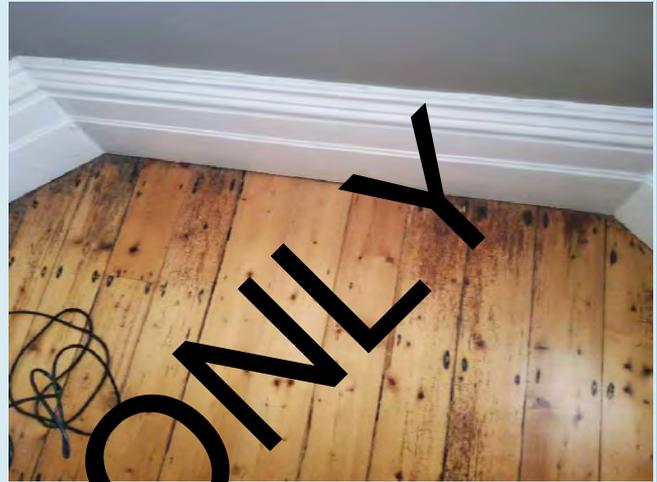
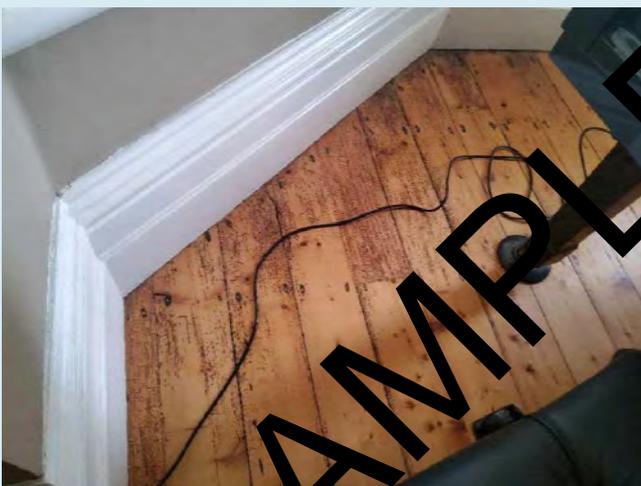
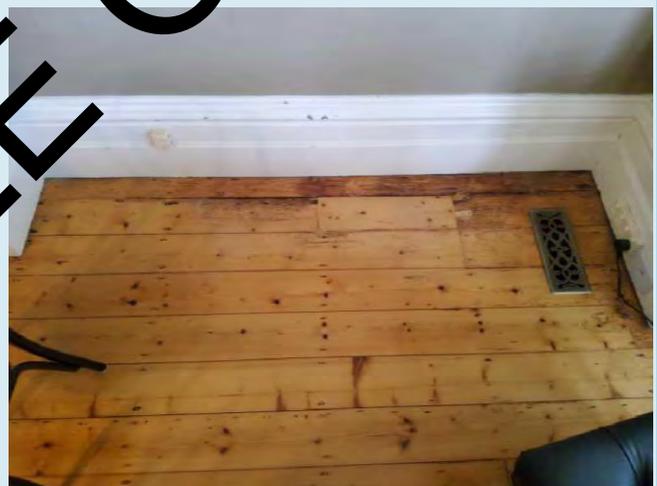
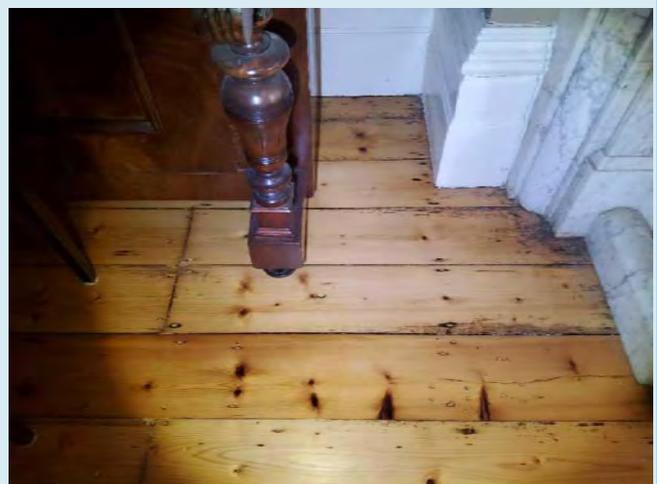
Living room - Furniture Beetle (borer) damage was found to floorboards, mainly near the west and south walls. Some floorboards appeared to have been replaced. Borer damage ranged from minor to very heavy. Heavily damaged floorboards should be replaced to avoid further damage and possible collapse. Recommend obtaining further information if possible from the vendors regarding past borer treatments and any warranty. See also the Timber Pest section of the report.

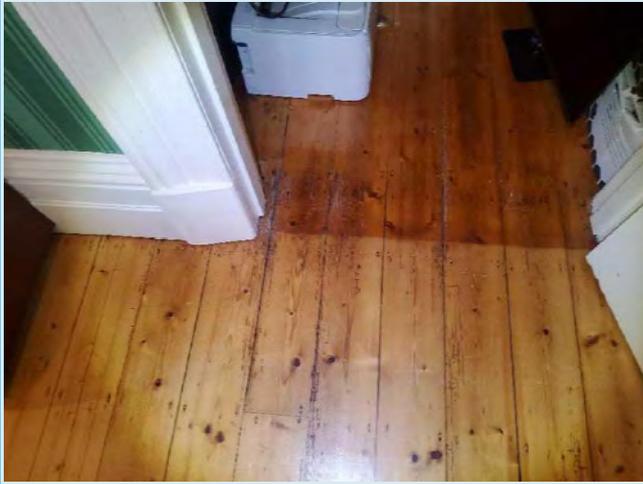
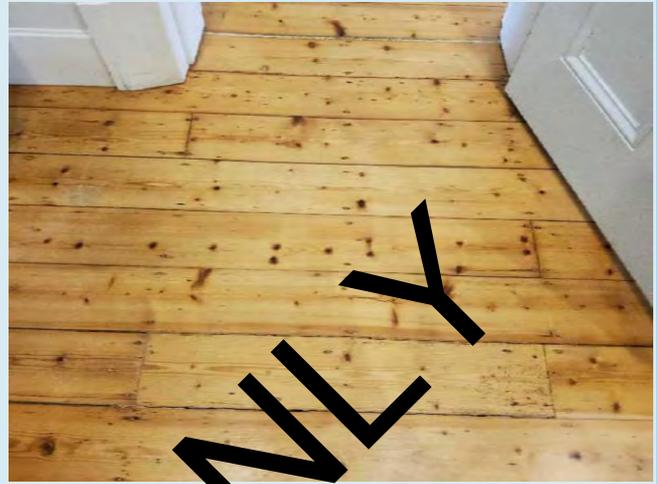
Hallways and general living spaces	
Major Defect	Floor
<b>Comments</b>	
Dining room - Minor, patchy borer damage found to several floorboards, see comment above and the timber pest section of the report.

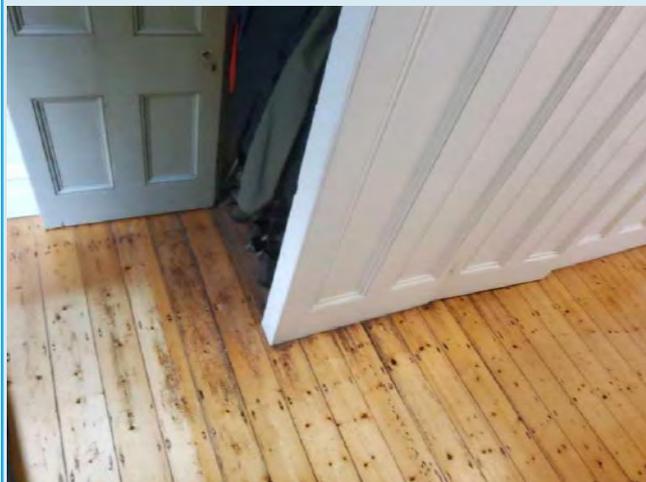
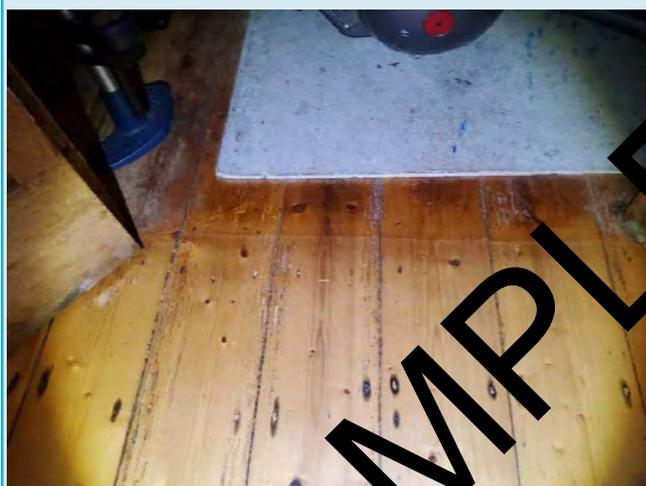
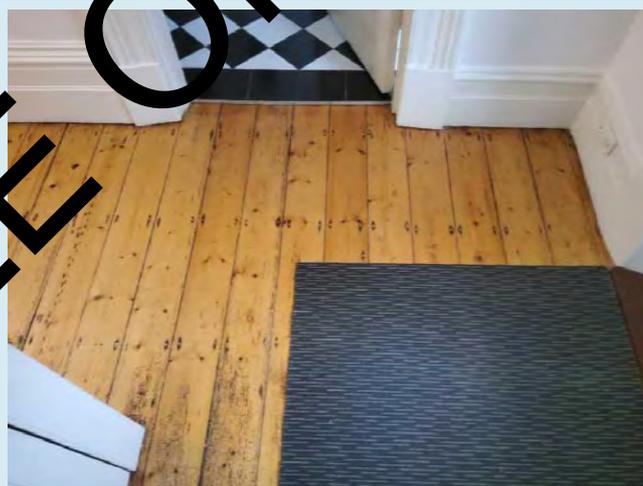
Minor to heavy borer damage found to floorboards at the end of the hallway, and inside cupboards below the stairs. Heavy damage should be replaced to avoid further damage. See comments above, and the timber pest section of report.

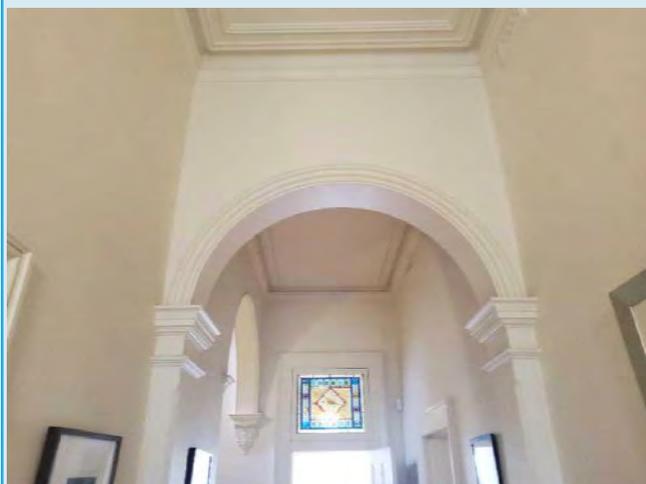
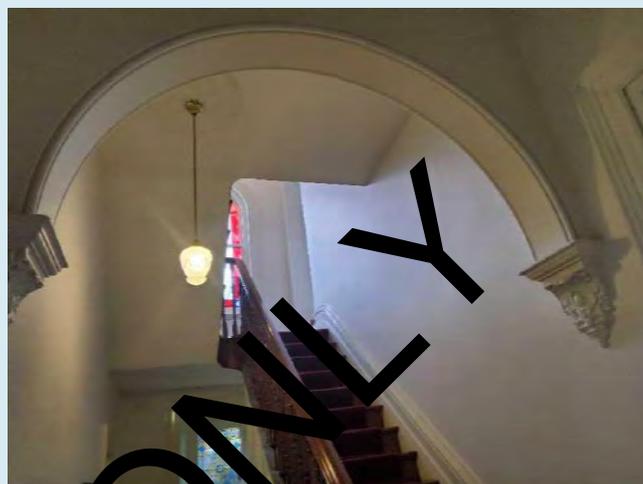
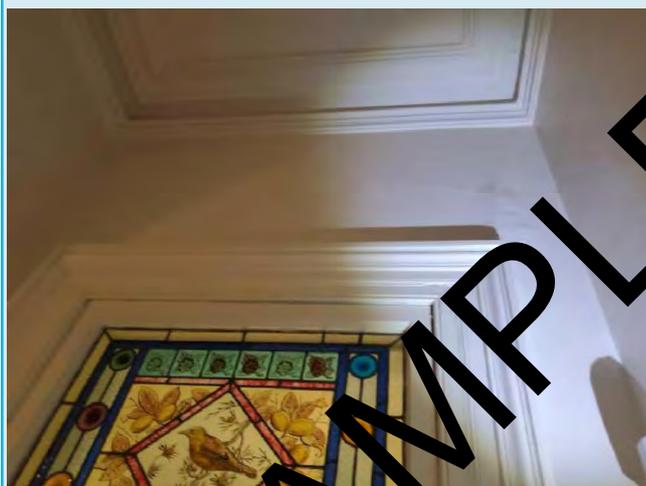
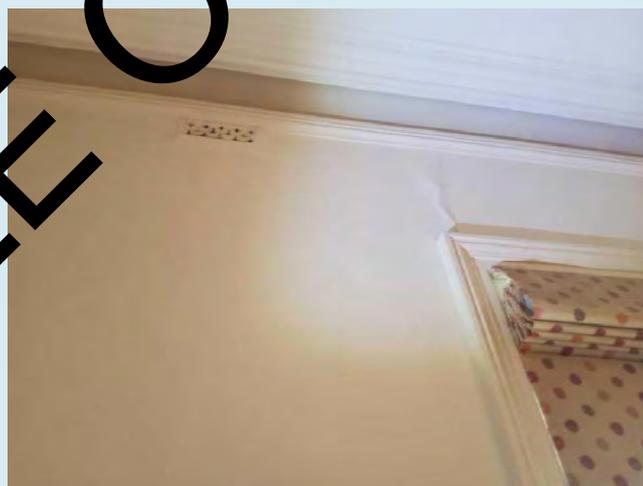
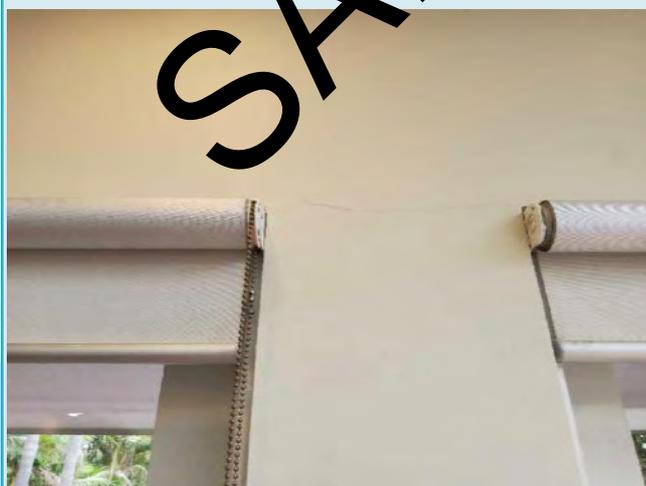
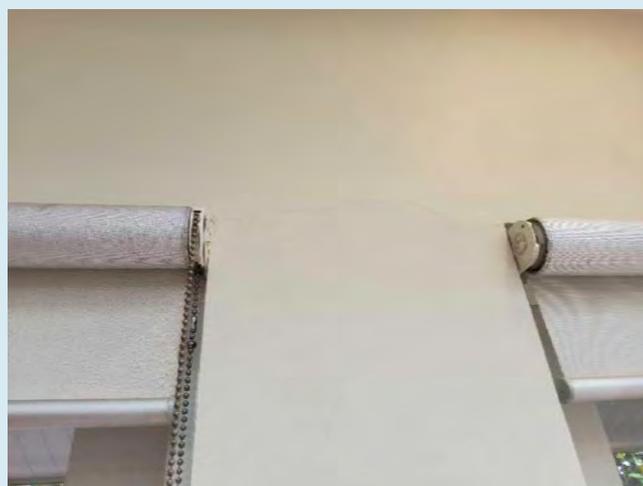
There are slight cracks to walls in a few places throughout, consistent with the age and type of construction and typical of minor settlement of footings over time.  
Patch and paint as required to improve appearance.  
Monitor cracks for any deterioration over time, and contact a structural engineer if cracks worsen significantly.

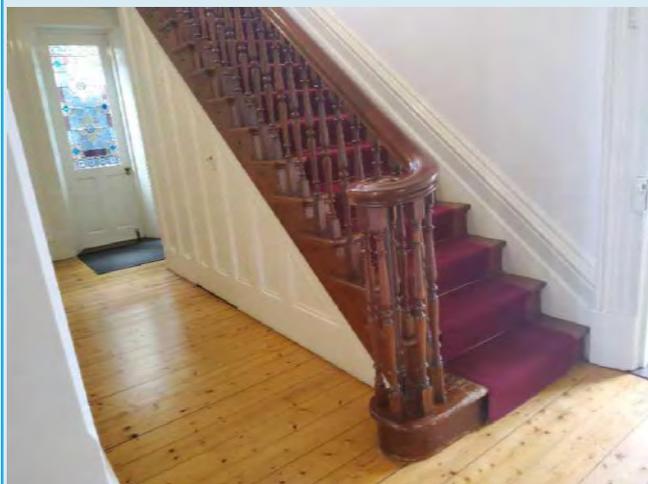
The lower baluster posts are loose, the balustrade sways slightly under pressure. Recommend maintenance repair soon to avoid further damage.

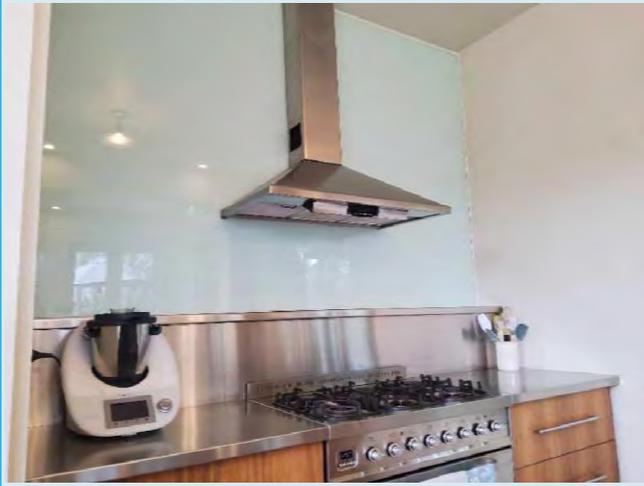
<b>Kitchen</b>	
<b>General Advice/Minor Defect</b>	<b>Appliances ( Oven, Range Hood, Dishwasher)</b>
<b>Comments</b>	
Range hood light not working. Recommend maintenance repair.

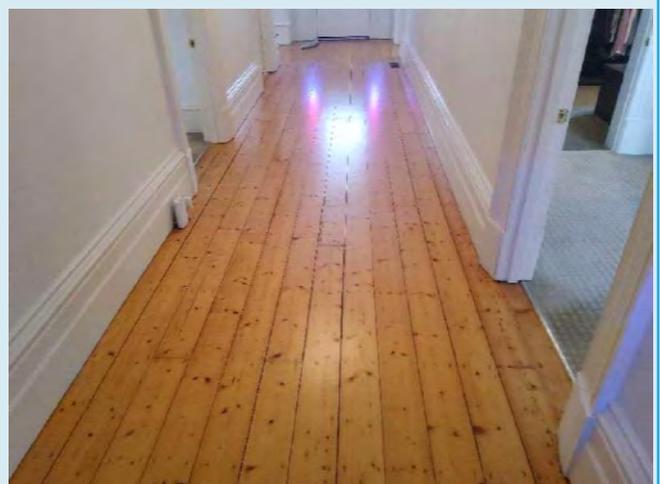
All upper level flooring was creaking slightly underfoot, bedroom floorboards covered by carpet. Recommend replacing carpets and a carpenter assess and rectify any loose nails or floorboards. Note that boiler damage or other damage may have occurred and further repairs may be required.

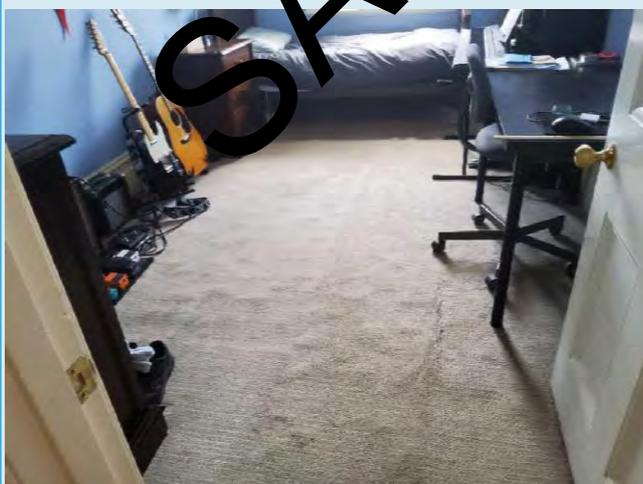
<b>Bedroom 3</b>	
<b>General Advice/Minor Defect</b>	<b>Floor</b>
<b>Comments</b>	
Loose carpets, slight creaks to floor boards underfoot.

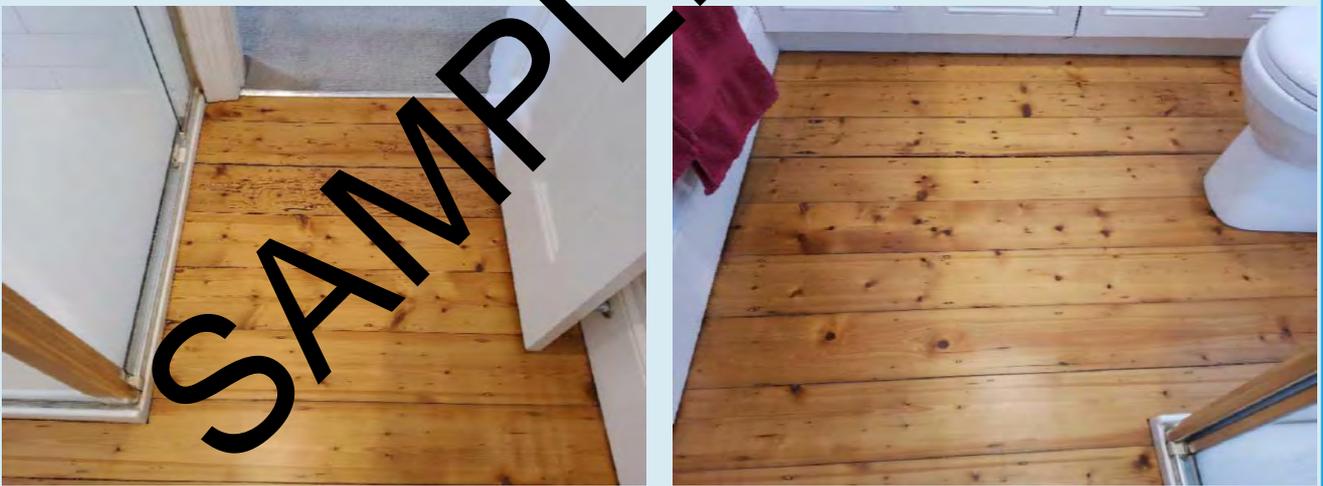
<b>Bathroom 2</b>	
<b>Major Defect</b>	<b>Floor</b>
<b>Comments</b>	
Minor, patchy borer damage found to several floorboards. See the hallways and living spaces comments and timber pest section of the report.

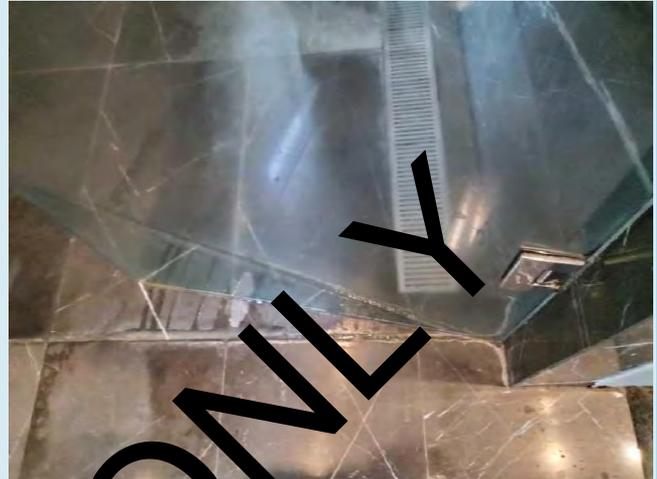
Shower screen was not sealed to the floor and can be moved. Moderate water damage noted to the bottom of the timber frame alongside.  
Recommend a maintenance contractor seal and secure the screen glass to prevent water escaping from this area and further damage to other areas.

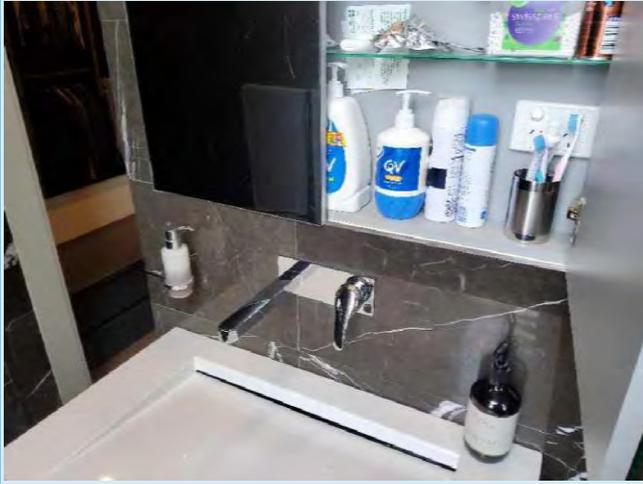
**Mirror doors to cabinet were jamming. Recommend maintenance repair.**

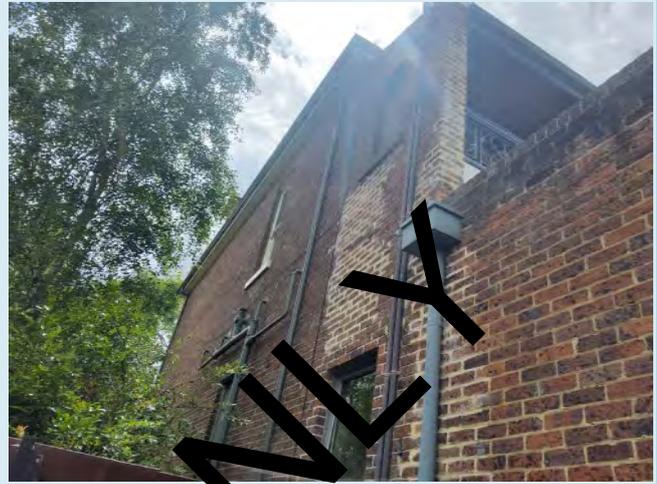
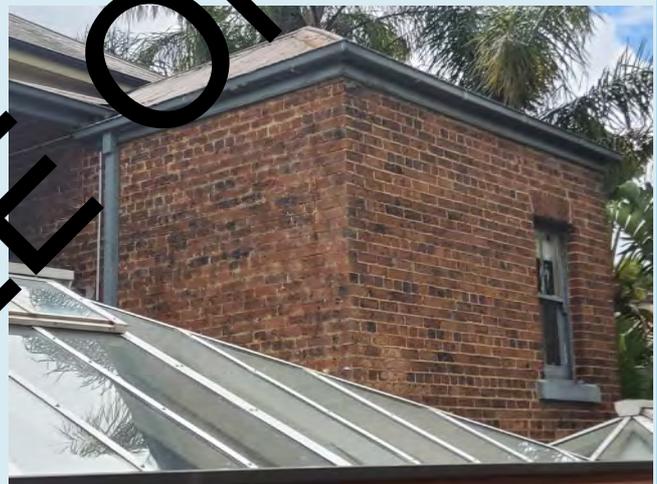
Widespread mortar patching noted to right side brickwork. No major damage was visible. Monitor all cracks and previously repaired walls for any further movement over time and if found contact a structural engineer.

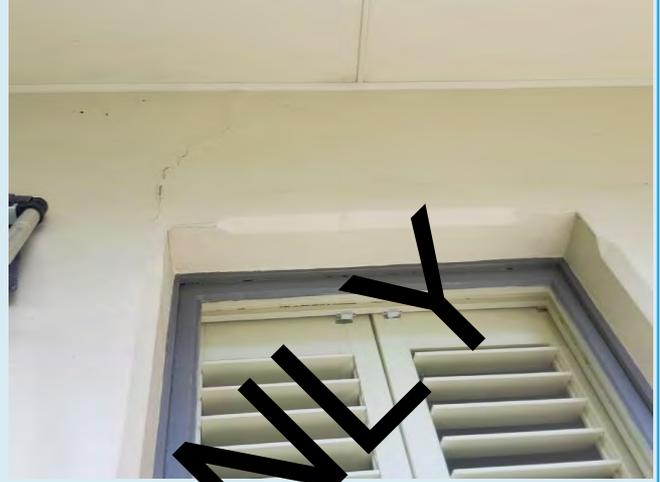
Slight cracks noted to front masonry wall.

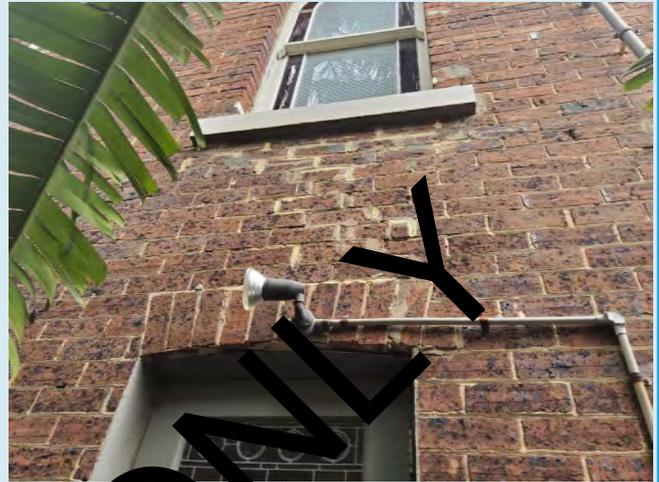
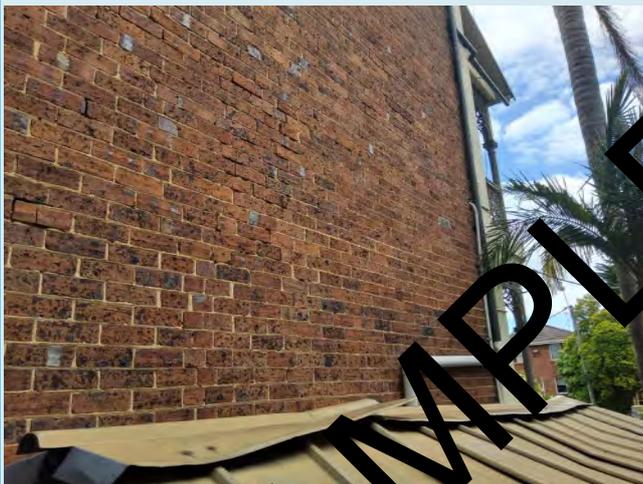
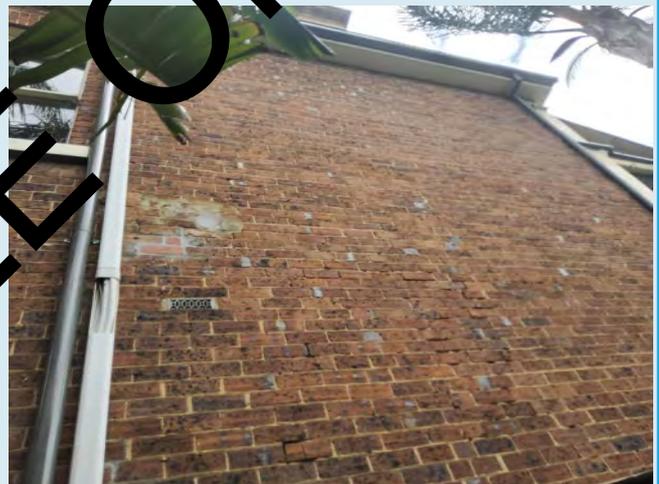
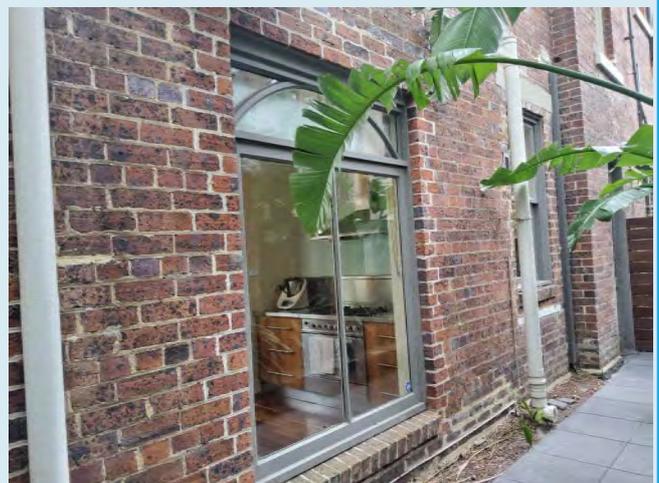
Some mortar patching noted to left side brickwork, stepped cracks and evidence of lateral movement of lower brickwork section below stepped crack. Monitor all cracks and previously damaged walls for any further movement over time and if found contact a structural engineer.

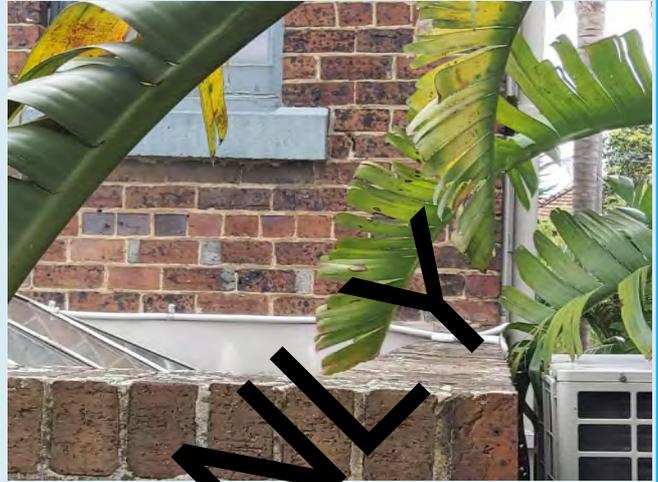
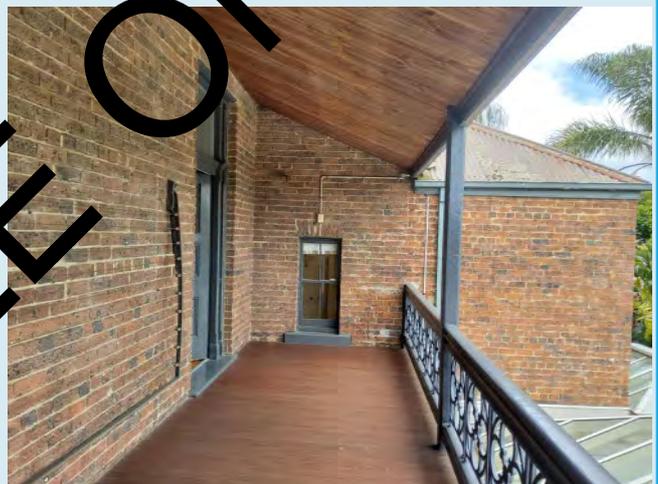
Slight stepped crack noted to rear wall, and the left corner. Other areas appeared visually fine.

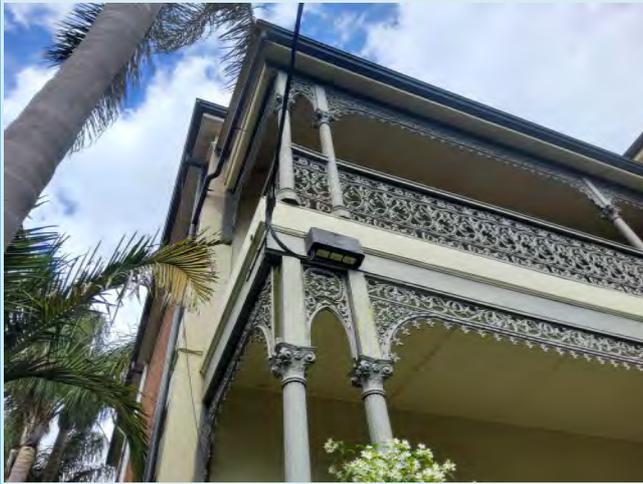
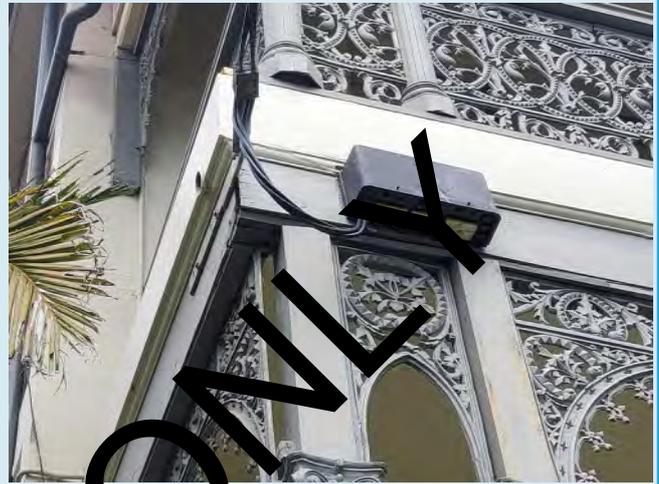
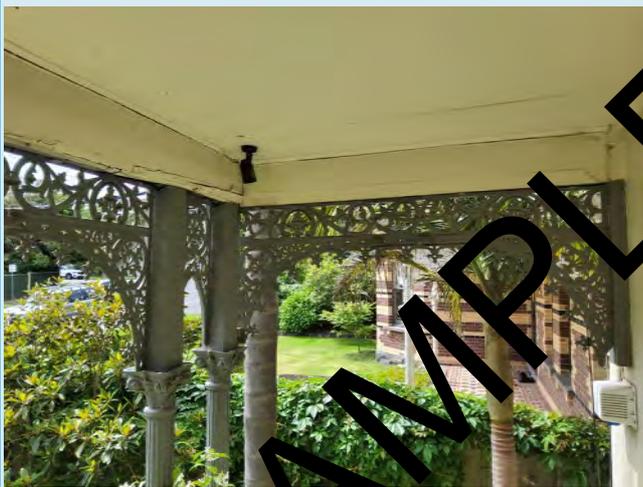
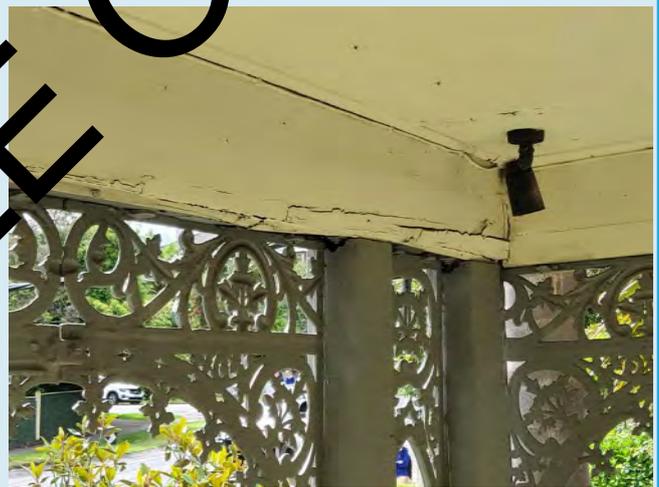
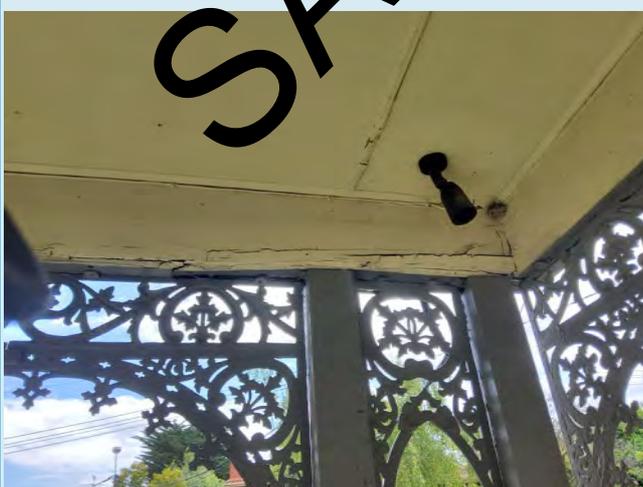
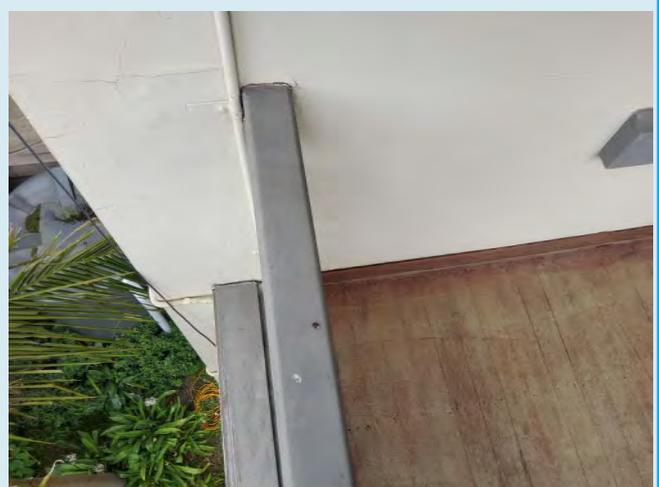
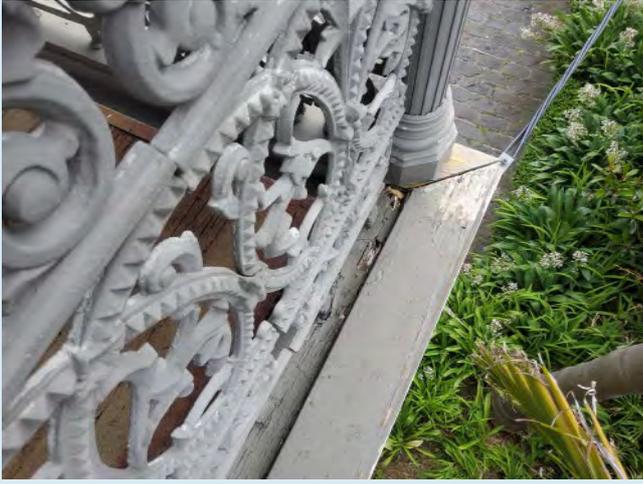
Major structural damage - the front verandah front beam was damaged with heavy fungal decay. The front verandah posts appear bowed outwards and to the left side in this corner, and the verandah floor has pulled away from the wall approximately 8mm. Recommend a builder be engaged to replace heavily damaged timbers. The verandah floor may need to be rebuilt to remove damaged timbers.

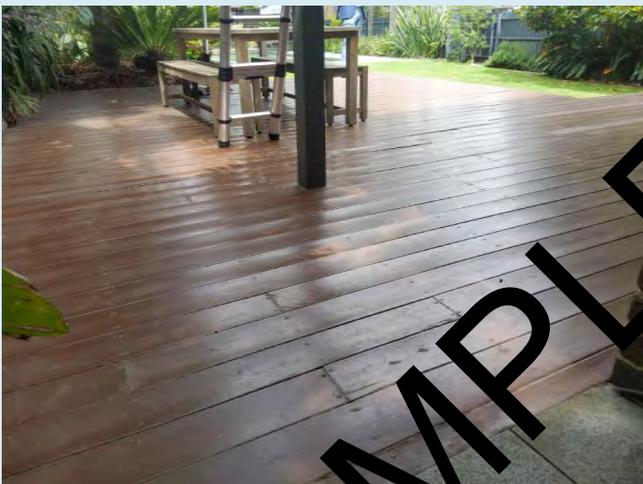
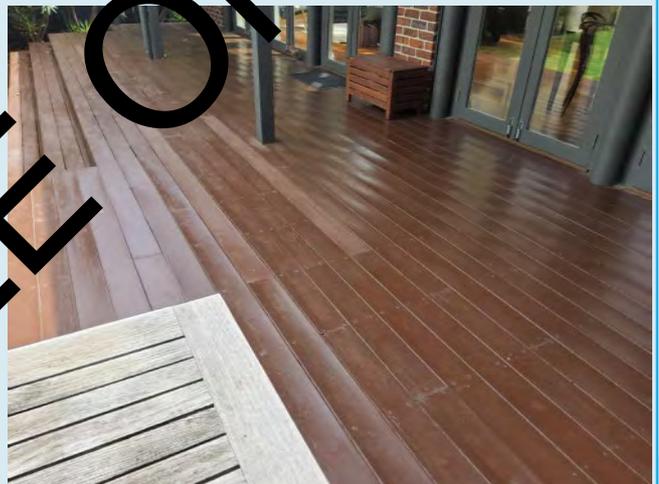
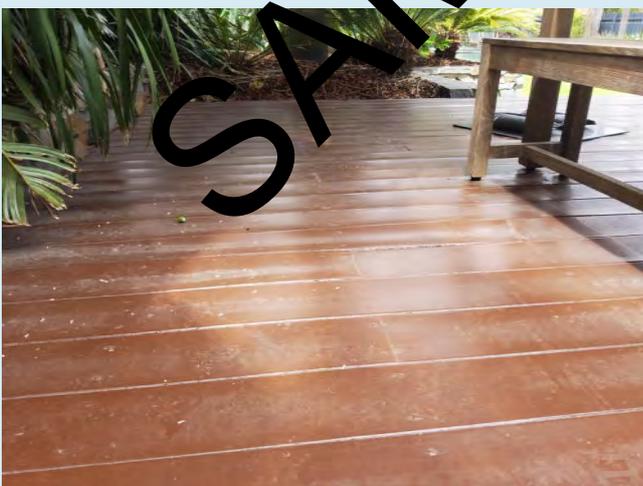
Rear deck floorboards were cupping, and damaged due to tight installation, and not painted underside. Recommend a qualified decking contractor rectify or replace floorboards to avoid long term damage and trip hazards.

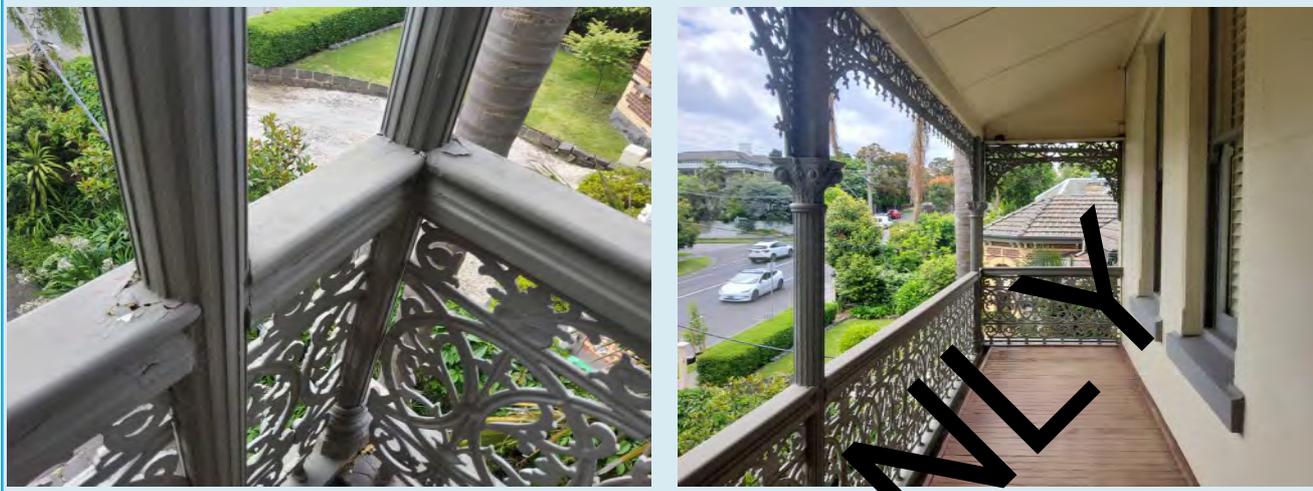
Front verandah handrails were slightly loose, and had minor decay at ends. Recommend repair when the front verandah is rectified.

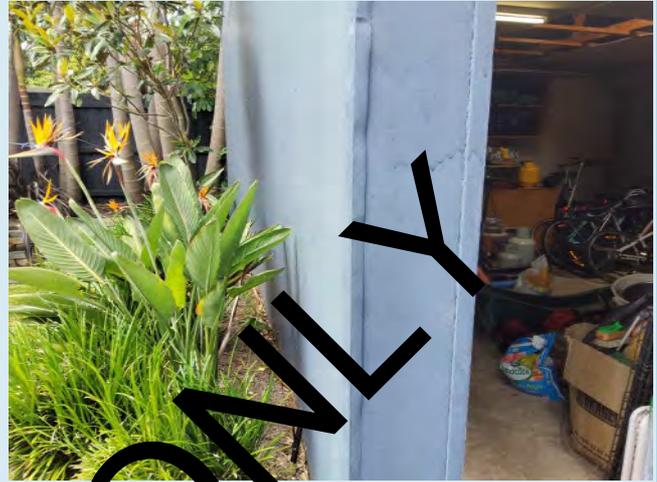
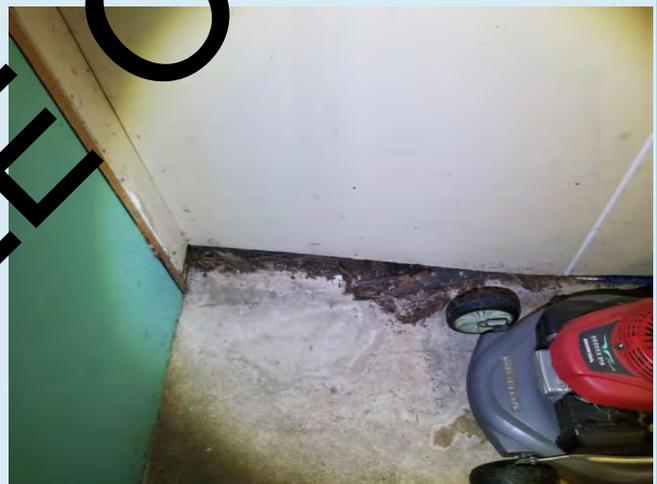
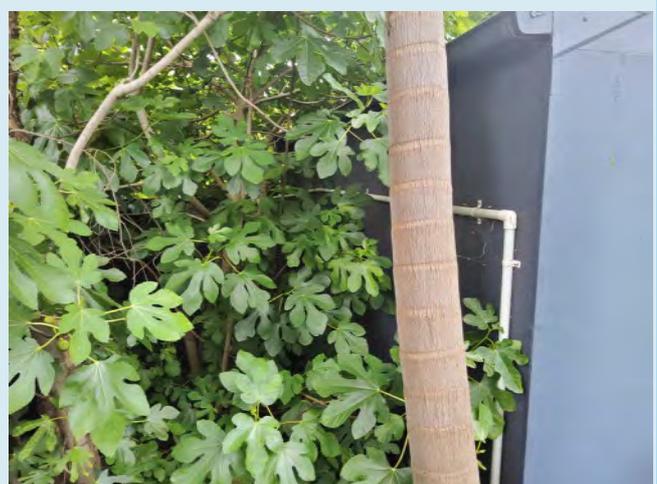
The front wall of the garage is concealed, but significantly bowed and heavy fungal decay found at the bottom of the wall suggests this was structurally damaged. Recommend replacing the wall with durable water resistant materials or remove the garden bed alongside to avoid ongoing damage. Left side wall was concealed, also has high garden beds and may also need repair or rebuilding.

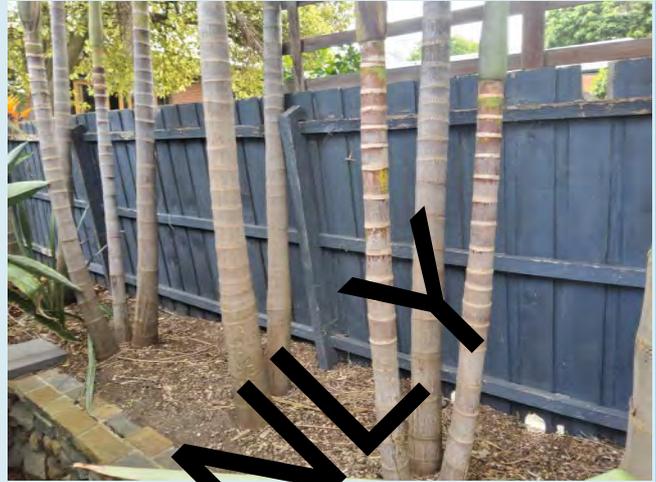
External > Exterior	
Major Defect	Fence
<b>Comments</b>	
The left side fence was leaning, with heavy fungal decay in places. Recommend replacing the fence soon.

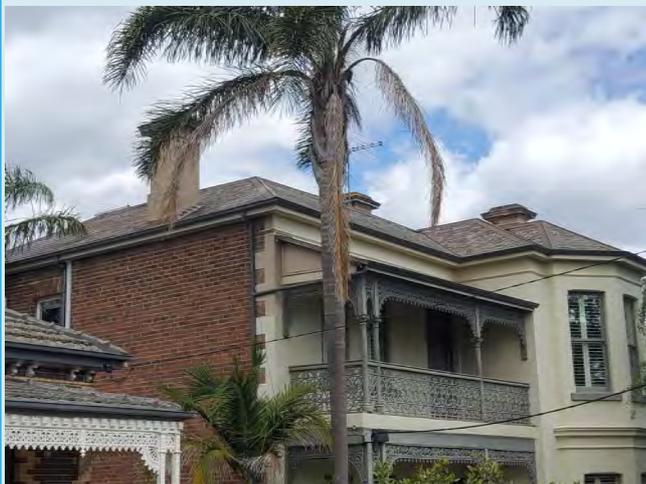
Upper level roof was unable to be safely accessed due to height restriction over 3.6m from the ground. This slate roof has a box gutter in the middle, so I recommend a further assessment by a qualified slate roofing contractor and roof plumber.

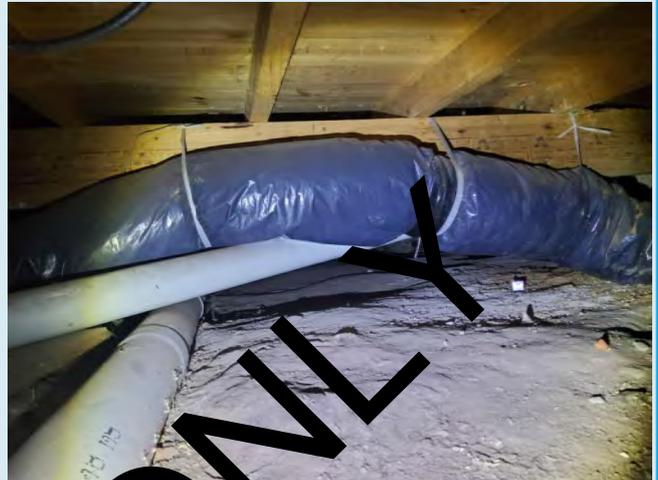
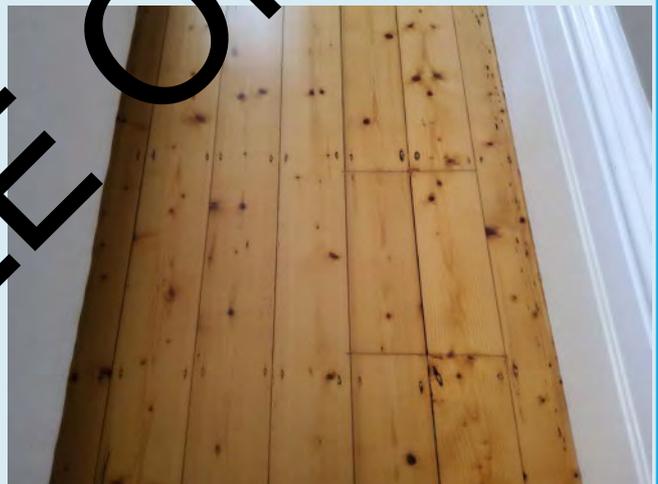
The subfloor area was unable to be inspected due to low clearance and obstructing ducts. Internal floorboard access traps have been sealed closed. Recommend a carpenter cut removable access traps in flooring for adequate assessment.

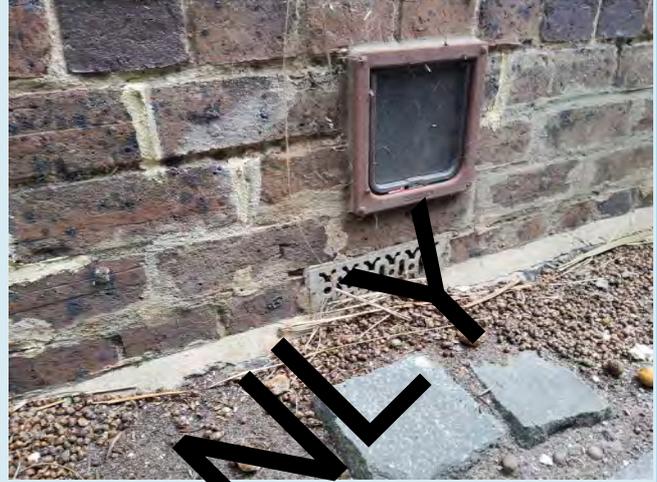
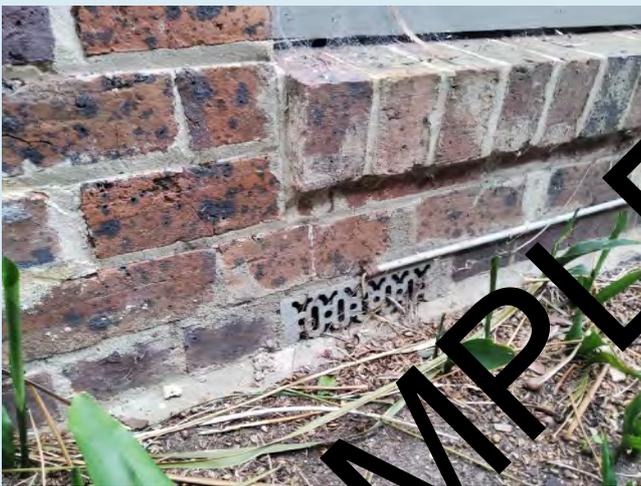
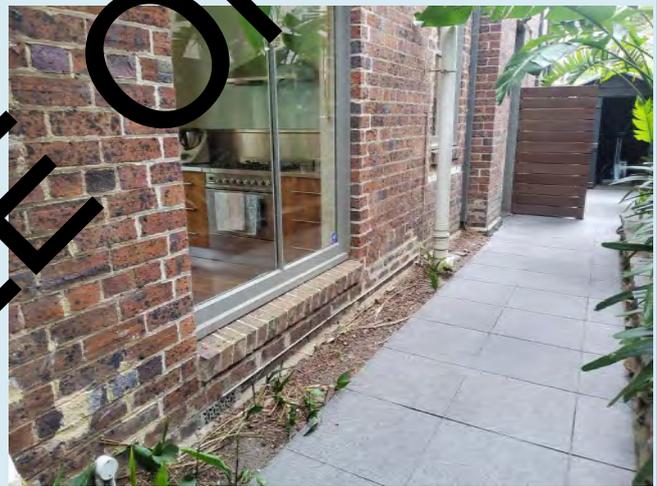
Subfloor ventilation is likely to be limited due to small vents. Recommend a subfloor ventilation contractor be engaged to improve subfloor ventilation via larger vents or an extraction fan system.

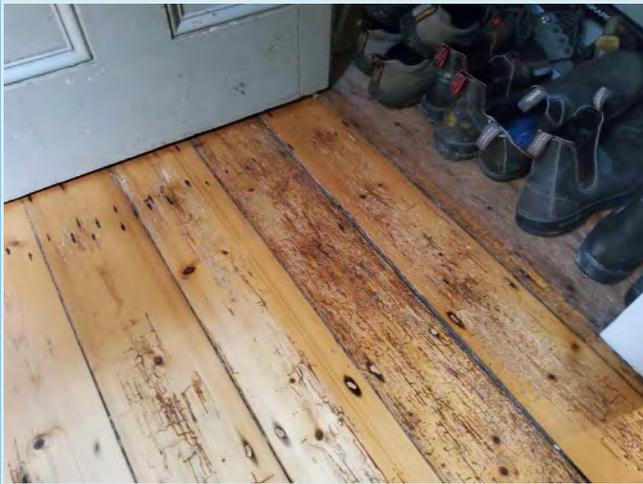
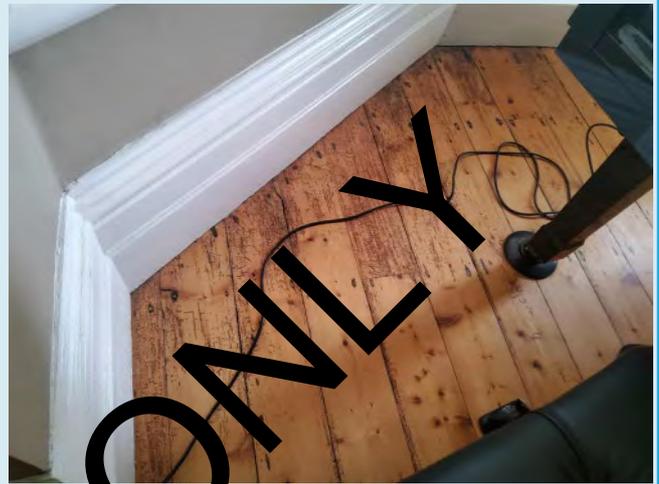
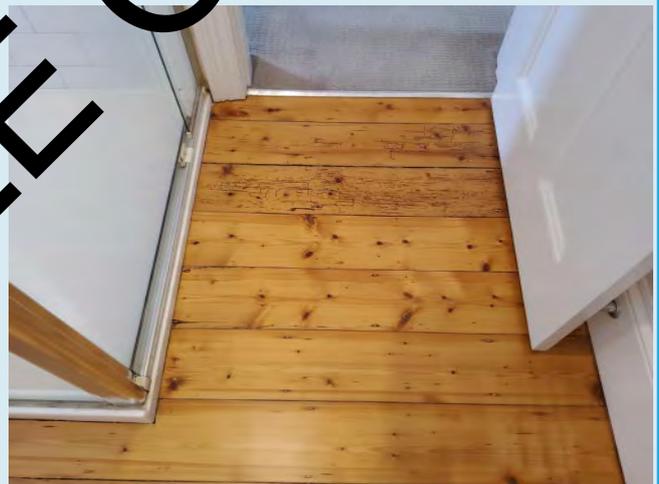
Evidence of Furniture Beetle borer damage (*Anobium* spp.) Was found to floorboards in several areas throughout the house. Some borer emergence holes were found, suggests borers were active. These borers damage timber slowly over a long period of time, but to the point of complete collapse. Recommend a pest control contractor be engaged to advise on treatment options and costs. The most reliable method of control is to replace the borer-damaged timbers and reduce conditions conducive to reinfestation, i.e. maximise subfloor ventilation, minimise damp conditions below the house.

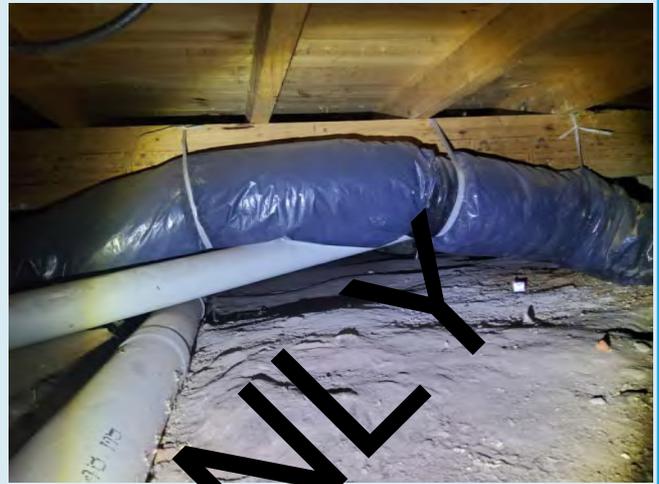
The subfloor area was unable to be inspected due to low clearance and ducts.

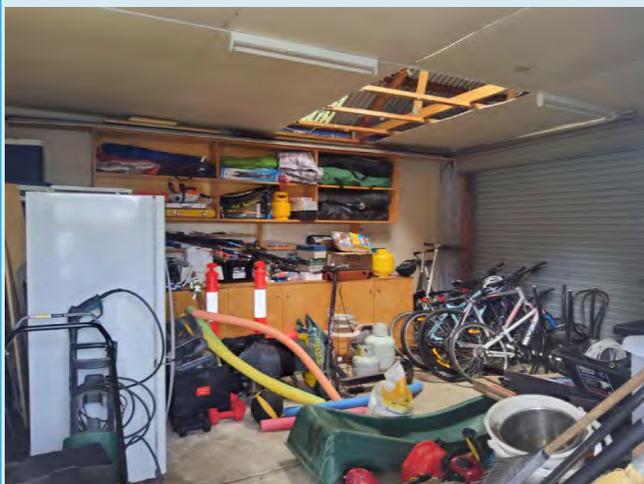
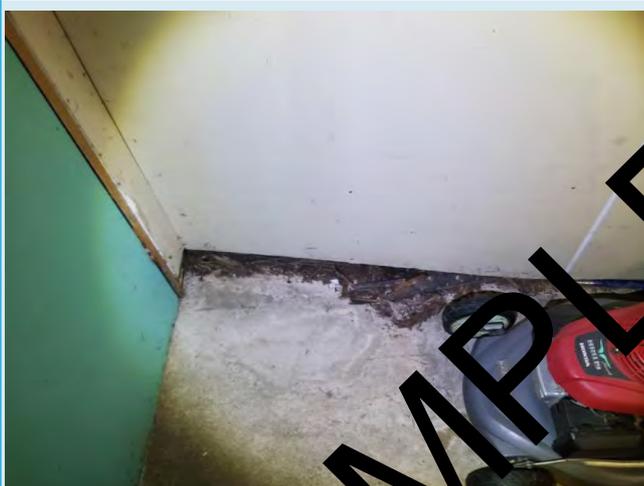
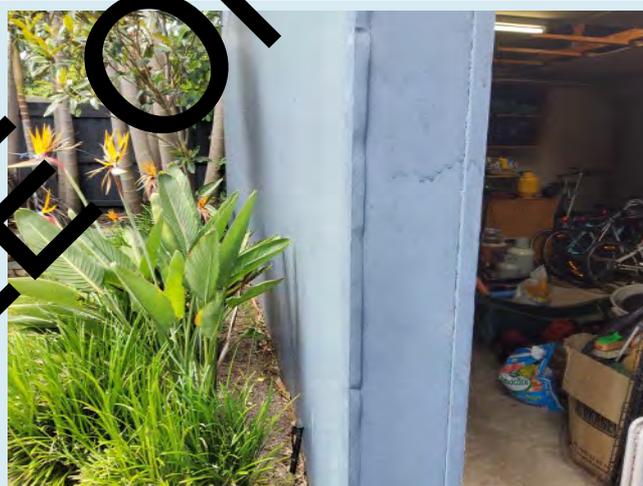
Very heavy fungal decay found to lower timber wall frames visible at the front of the garage. See garage comments in the building section of report.

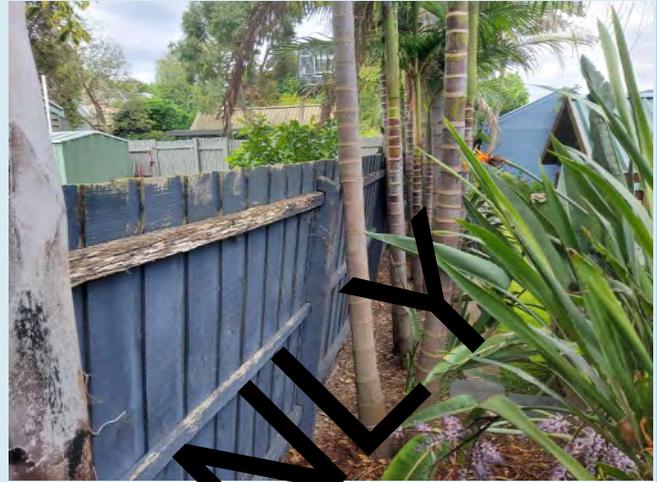
Timber Pest checklist findings	
Activity or Damage Advice on Item	Fence line
<b>Comments</b>	
Heavy fungal decay in places, see the fences comments in building section of the report.

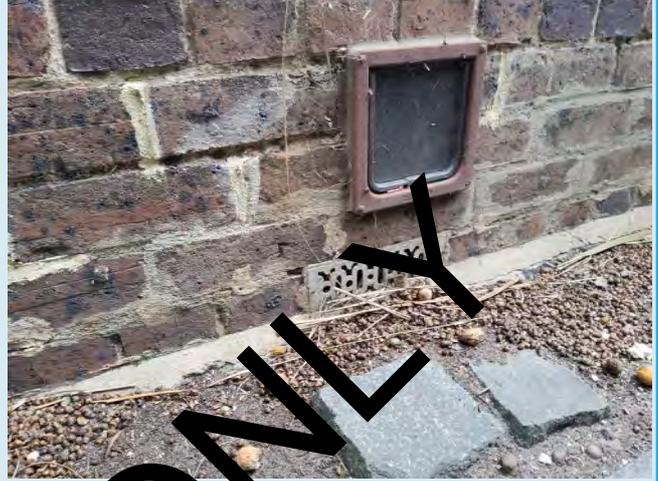
Subfloor ventilation is limited due to small vents and increases the risk of ongoing timber pest infestation (borers, termites and fungal decay). Recommend a subfloor ventilation contractor be engaged to improve subfloor ventilation via larger vents or an extraction fan system.

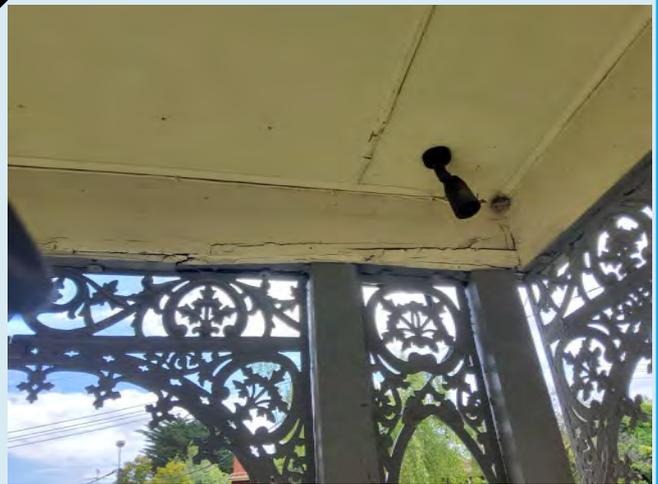
The front verandah beam had heavy fungal decay and evidence of structural movement, which should be rectified as soon as possible. See the building section comments.
