## Building & Pest Inspection Report

Building & Pest Inspection Report

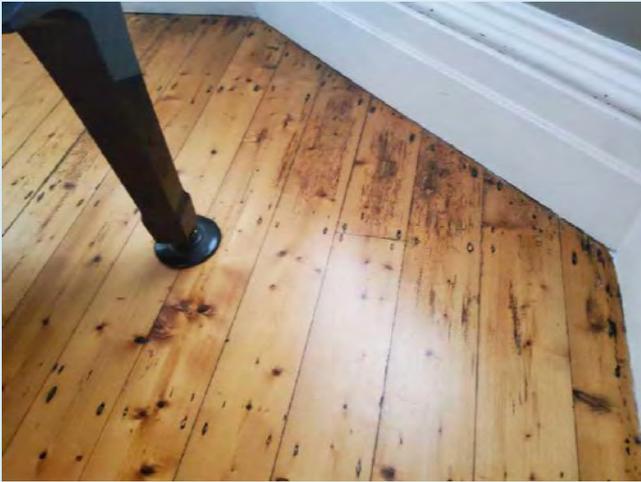
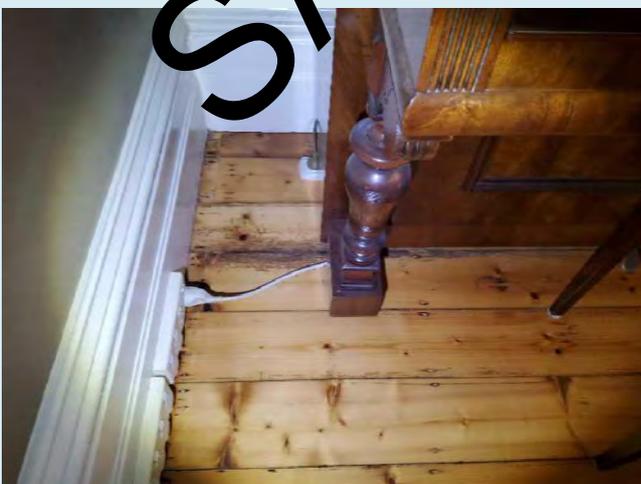
Living room - Furniture Beetle (borer) damage was found to floorboards, mainly near the west and south walls. Some floorboards appeared to have been replaced. Borer damage ranged from minor to very heavy. Heavily damaged floorboards should be replaced to avoid further damage and possible collapse. Recommend obtaining further information if possible from the vendors regarding past borer treatments and any warranty. See also the Timber Pest section of the report.

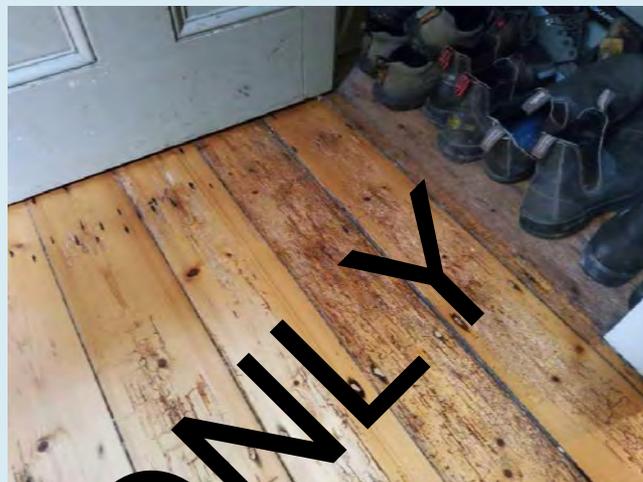
Minor to heavy borer damage found to floorboards at the end of the hallway, and inside cupboards below the stairs. Heavy damage should be replaced to avoid further damage. See comments above, and the timber pest section of report.

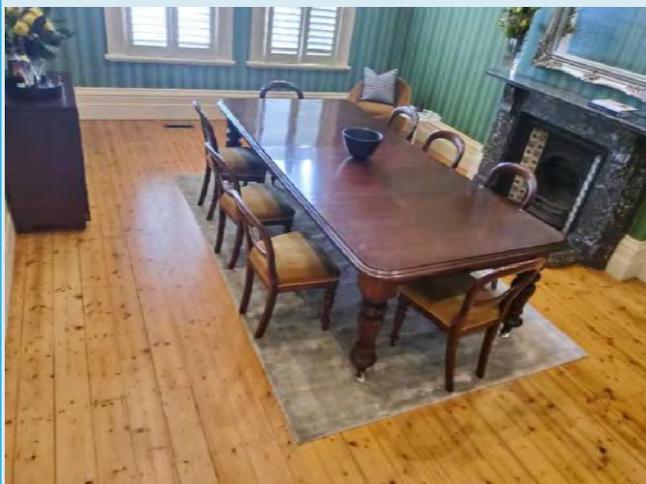
Slightly springy flooring in places. Blocking the stumps below the floor may be required in future. Contact a restumping contractor for more advice.

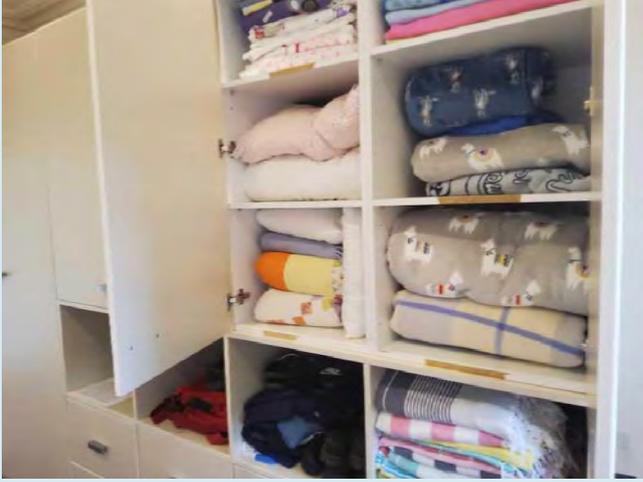
<b>Laundry</b>	
<b>General Advice/Minor Defect</b>	<b>Cabinets</b>
<b>Comments</b>	
Minor wear and tear deterioration in places.

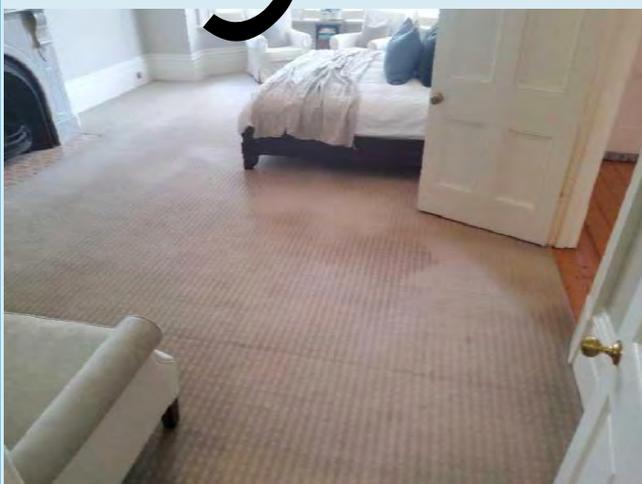
All upper level flooring was creaking slightly underfoot, bedroom floorboards covered by carpet. Recommend replacing carpets and a carpenter assess and rectify any loose nails or floorboards. Note that boiler damage or other damage may have occurred and further repairs may be required.

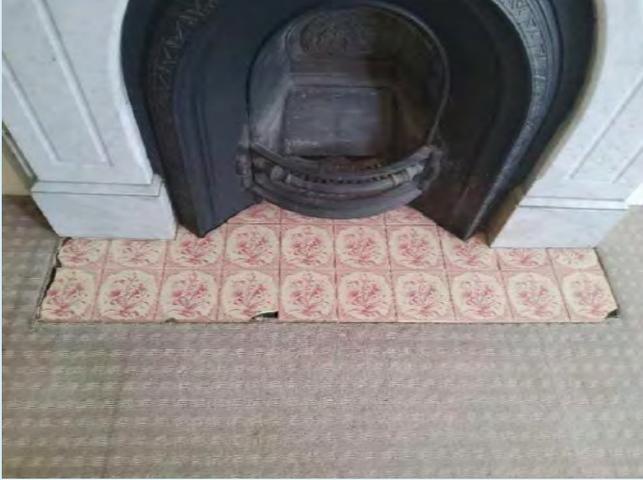
<b>Bedroom 1</b>	
<b>General Advice/Minor Defect</b>	<b>Floor</b>
<b>Comments</b>	
Hearth tiles are damaged in a few places.

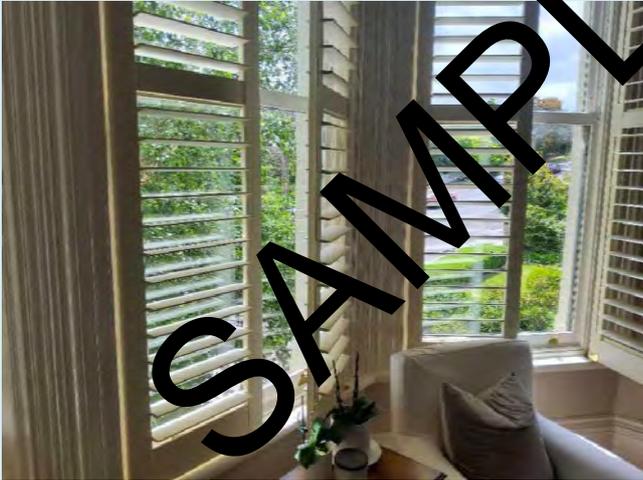
<b>Bedroom 1</b>	
<b>General Advice/Minor Defect</b>	<b>Windows</b>
<b>Comments</b>	
The windows are painted closed. To make openable for natural ventilation, contact a window repair contractor.

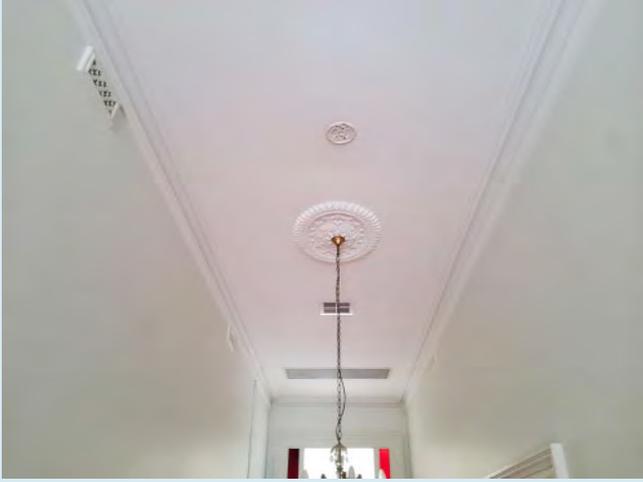
<b>Bedroom 1</b>	
<b>General Advice/Minor Defect</b>	<b>Smoke Detectors</b>
<b>Comments</b>	
Install a smoke detector outside the bedrooms for safety.

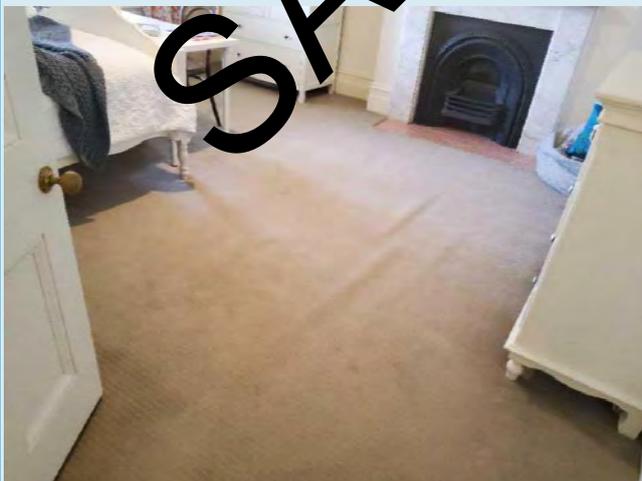
Loose carpets, slight creaks to floorboards underfoot.

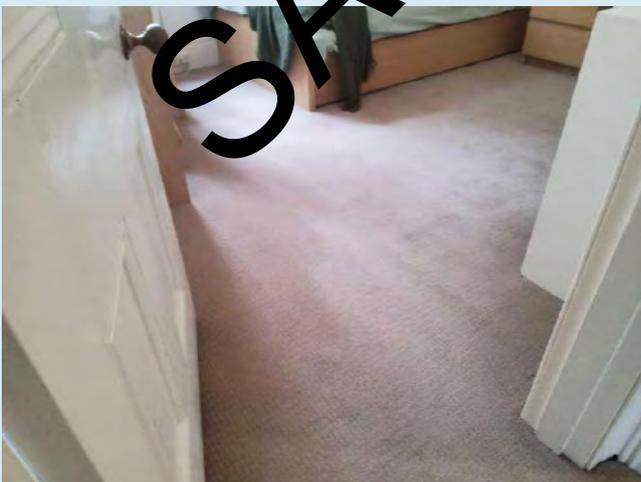
Loose carpets, slight creaks to floorboards underfoot.

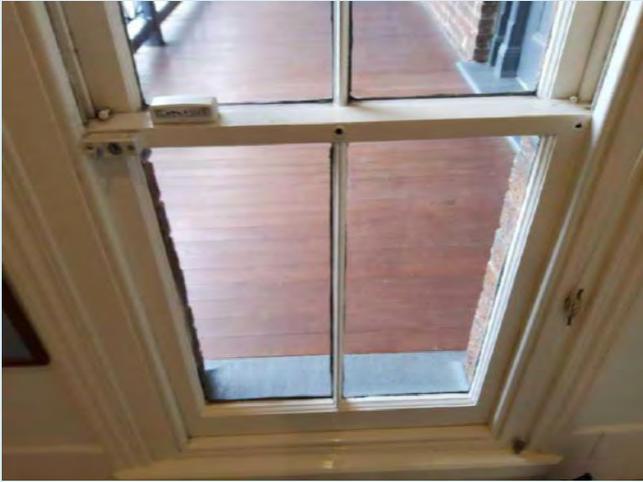
<b>Bathroom 2</b>	
<b>General Advice/Minor Defect</b>	<b>Windows</b>
<b>Comments</b>	
Window has been screwed in place and painted closed.

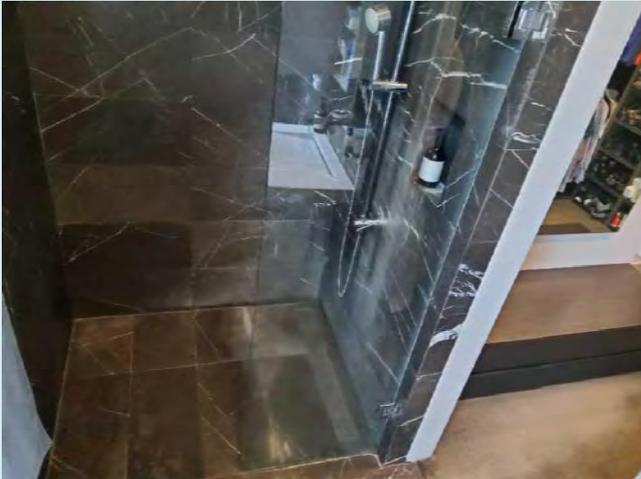
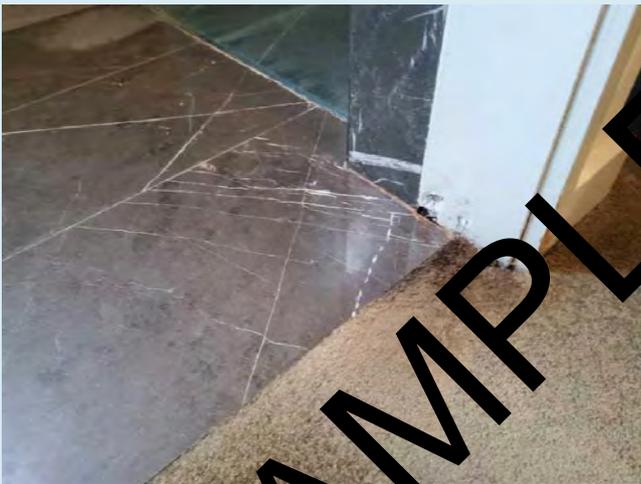
Shower screen was not sealed to the floor and can be moved. Moderate water damage noted to the bottom of the timber frame alongside.  
Recommend a maintenance contractor seal and secure the screen glass to prevent water escaping from this area and further damage to other areas.

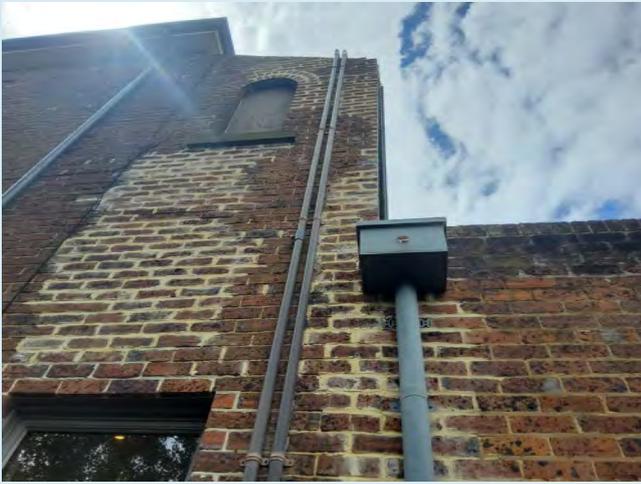
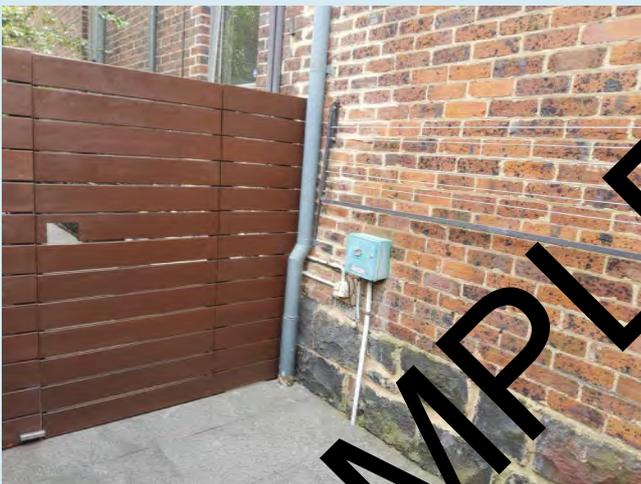
Widespread mortar patching noted to right side brickwork. No major damage was visible. Monitor all cracks and previously repaired walls for any further movement over time and if found contact a structural engineer.

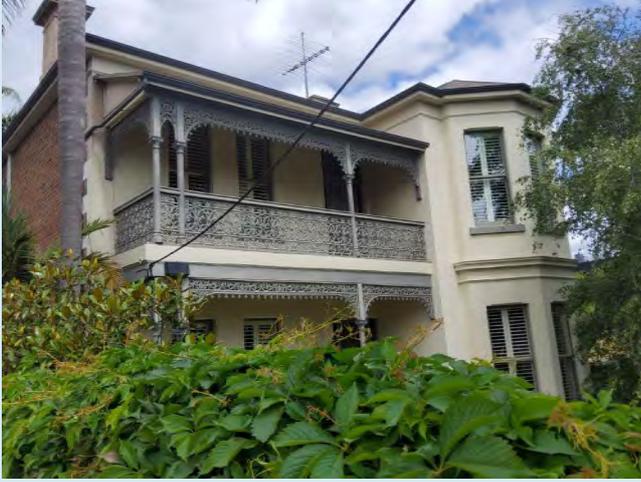
Slight cracks noted to front masonry wall.

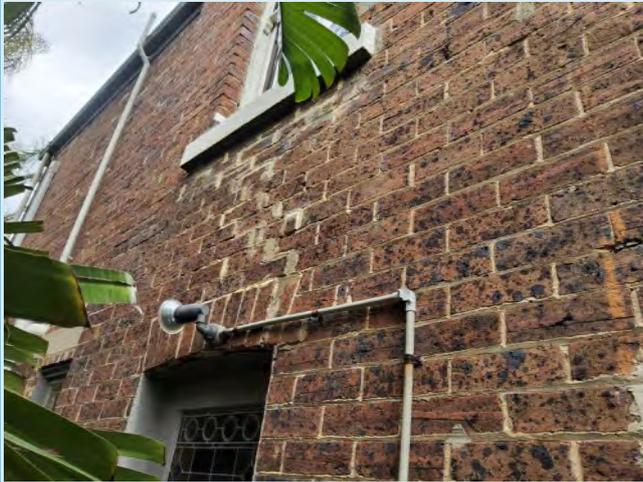
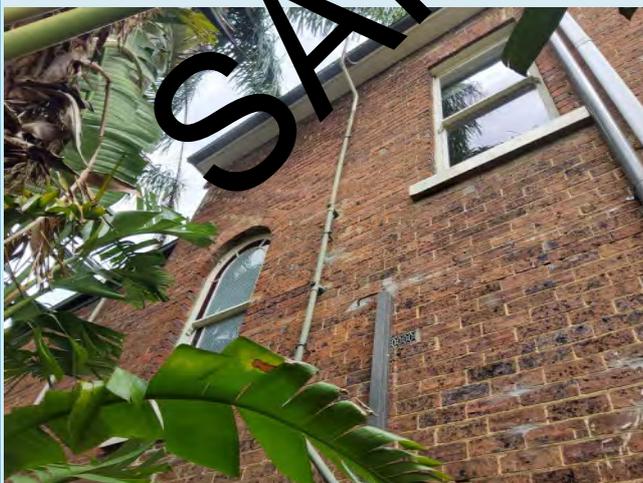
Some mortar patching noted to left side brickwork, stepped cracks and evidence of lateral movement of lower brickwork section below stepped crack. Monitor all cracks and previously damaged walls for any further movement over time and if found contact a structural engineer.

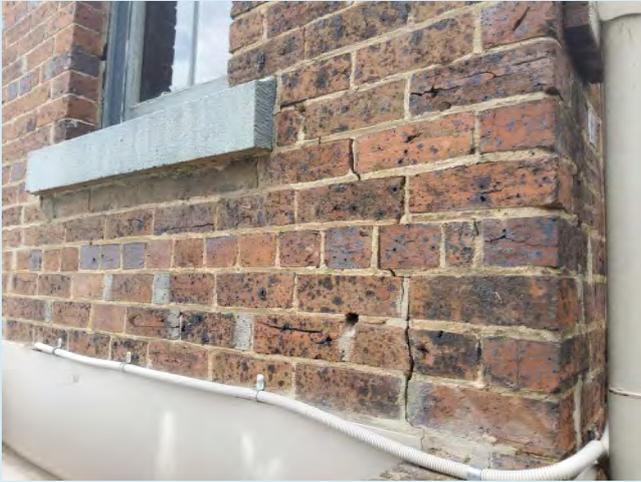
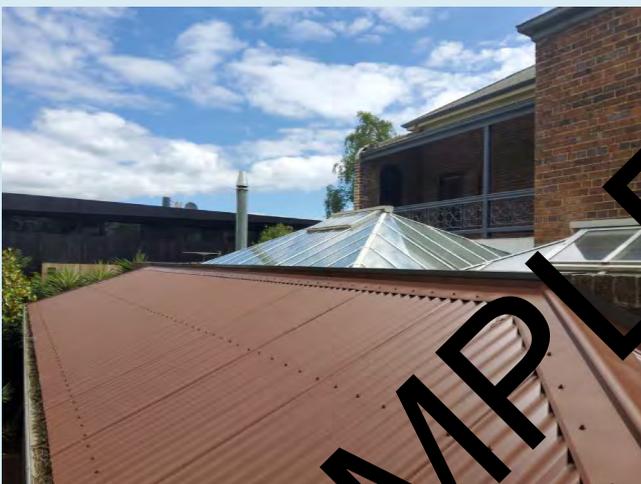
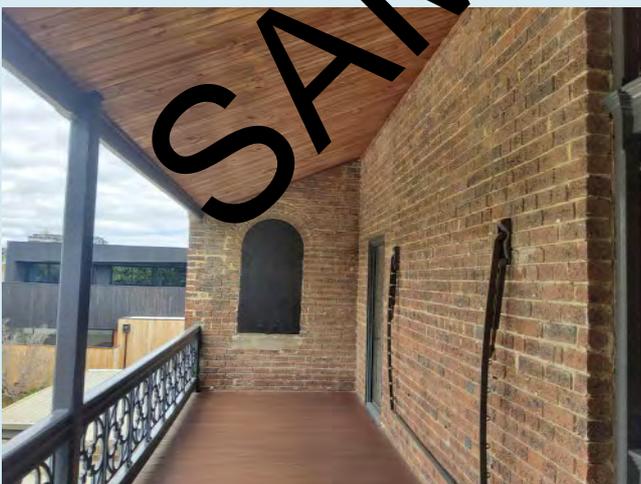
Slight stepped crack noted to rear wall, and the left corner. Other areas appeared visually fine.

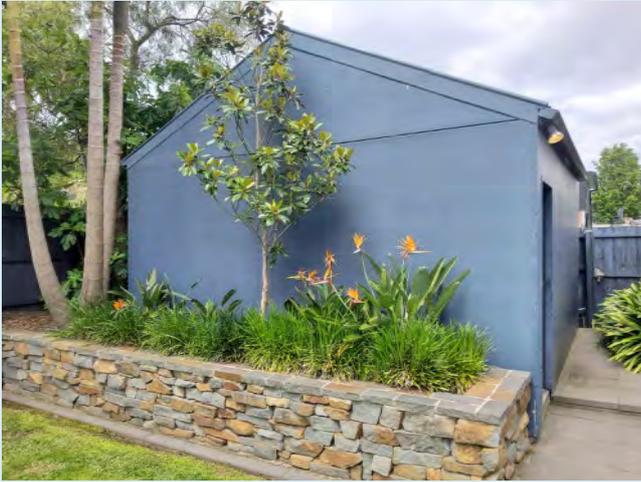
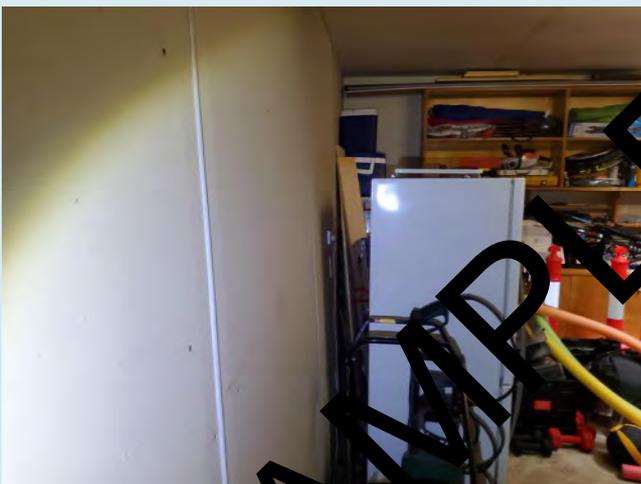
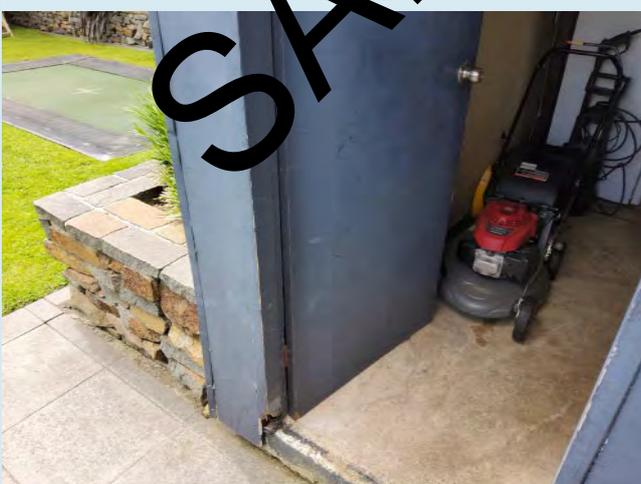
The front wall of the garage is concealed, but significantly bowed and heavy fungal decay found at the bottom of the wall suggests this was structurally damaged. Recommend replacing the wall with durable water resistant materials or remove the garden bed alongside to avoid ongoing damage. Left side wall was concealed, also has high garden beds and may also need repair or rebuilding.

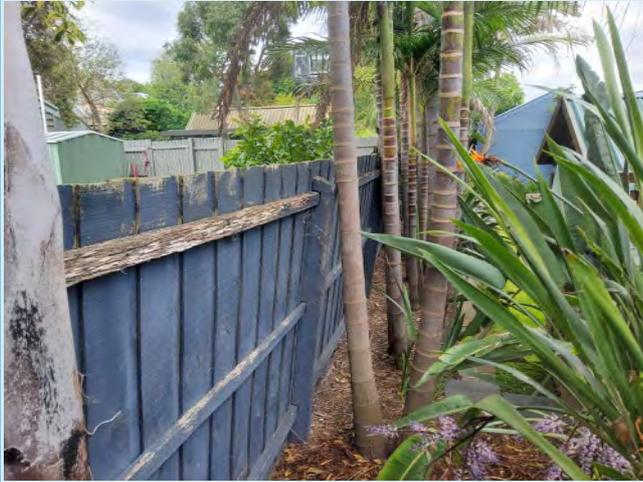
External > Exterior	
Major Defect	Fence
<b>Comments</b>	
The left side fence was leaning, with heavy fungal decay in places. Recommend replacing the fence soon.

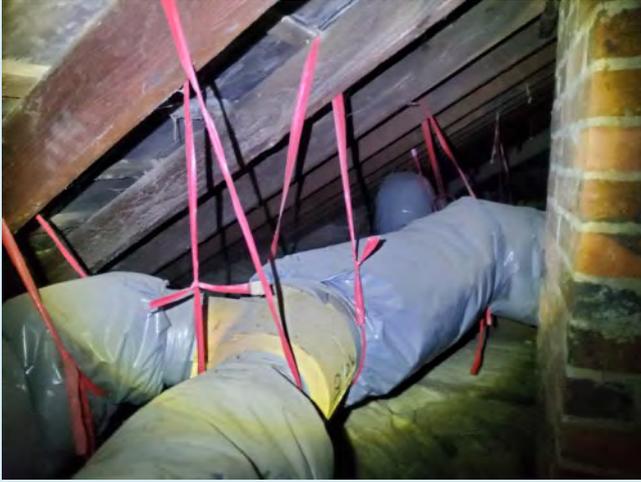
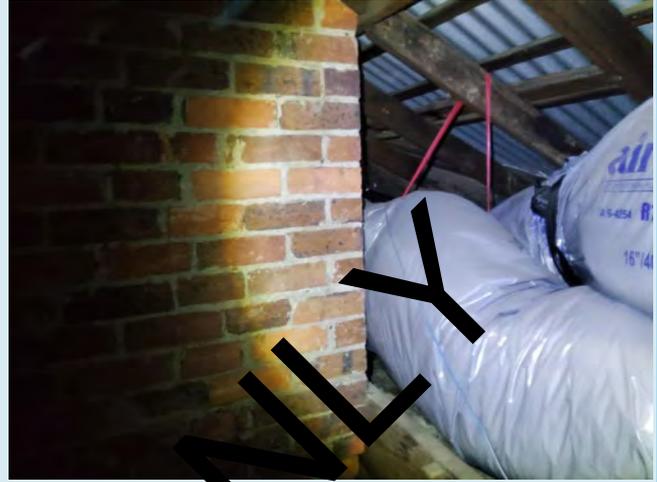
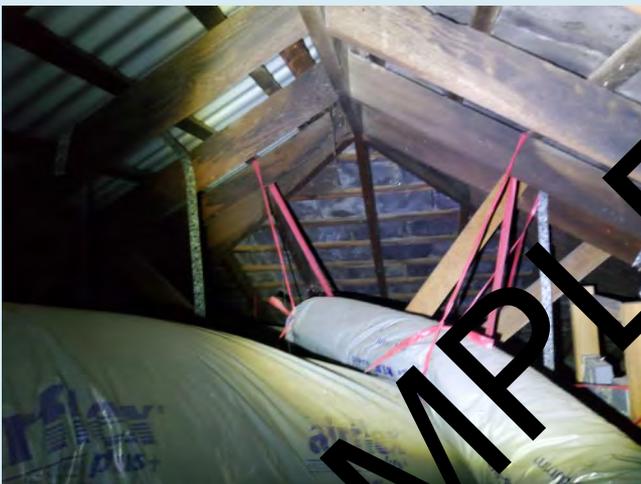
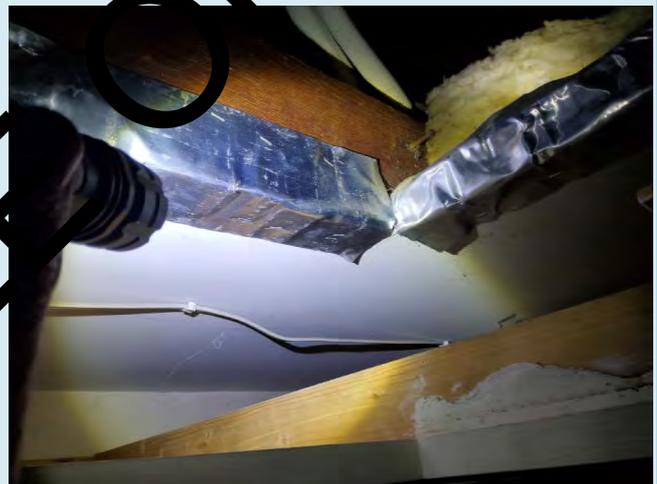
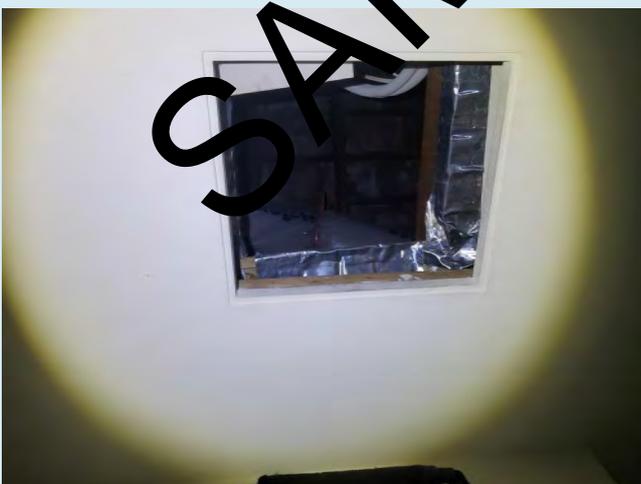
Roof space inspection was very limited - low clearance, insulation and ducts. Timber structure appeared fine where visible from the access trap.

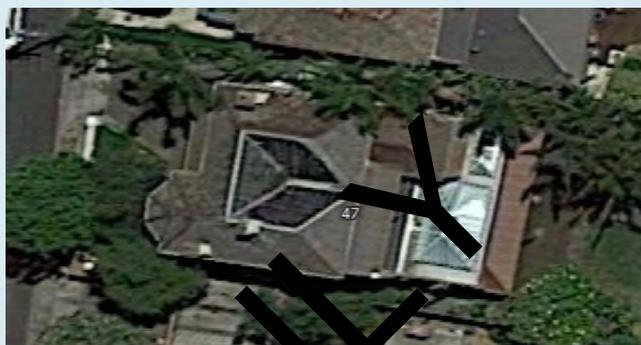
Upper level roof was unable to be safely accessed due to height restriction over 3.6m from the ground. This slate roof has a box gutter in the middle, so I recommend a further assessment by a qualified slate roofing contractor and roof plumber.

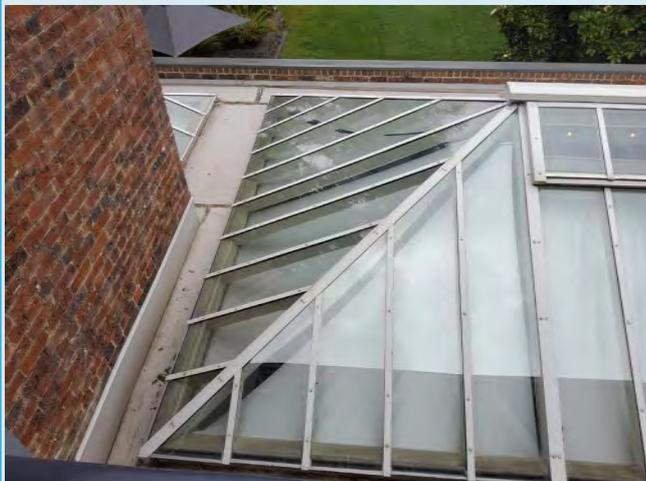
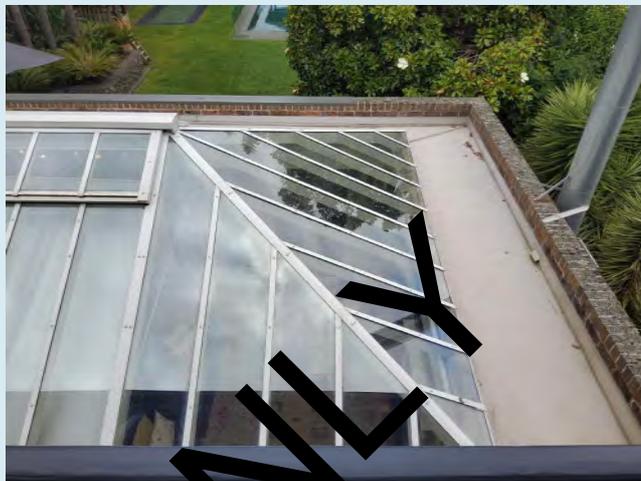
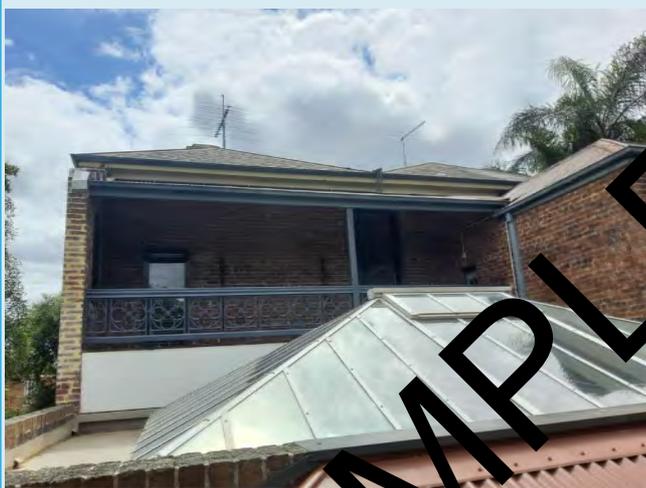
Lower level glazed roofs, gutters and flashing appeared visually fine.

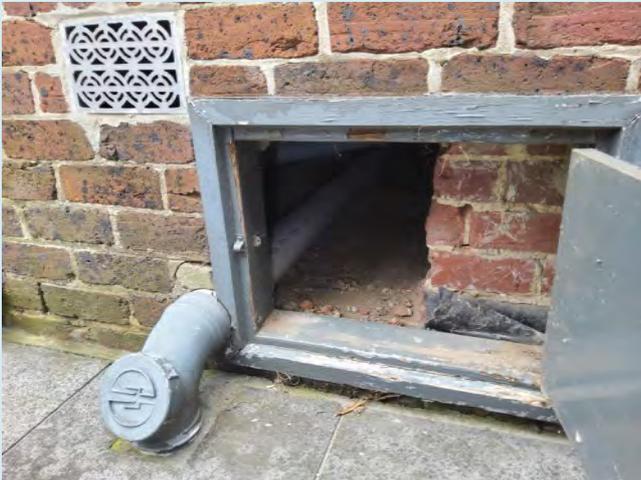
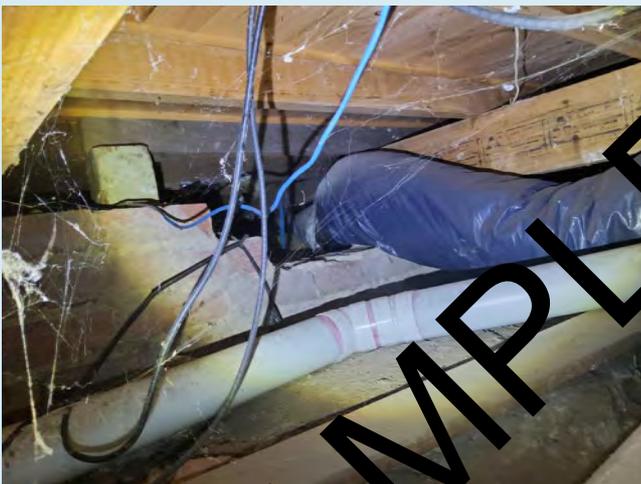
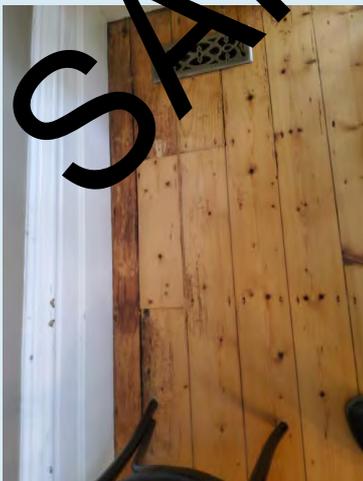
The subfloor area was unable to be inspected due to low clearance and obstructing ducts. Internal floorboard access traps have been sealed closed. Recommend a carpenter cut removable access traps in flooring for adequate assessment.

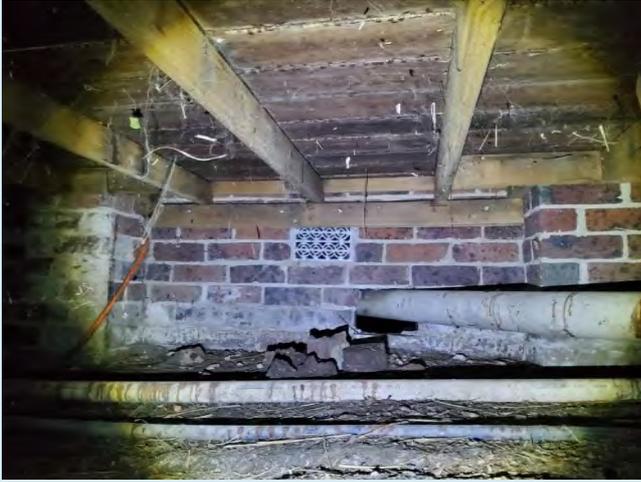
Subfloor ventilation is likely to be limited due to small vents. Recommend a subfloor ventilation contractor be engaged to improve subfloor ventilation via larger vents or an extraction fan system.

Subfloor ventilation is limited due to small vents and increases the risk of ongoing timber pest infestation (borers, termites and fungal decay). Recommend a subfloor ventilation contractor be engaged to improve subfloor ventilation via larger vents or an extraction fan system.

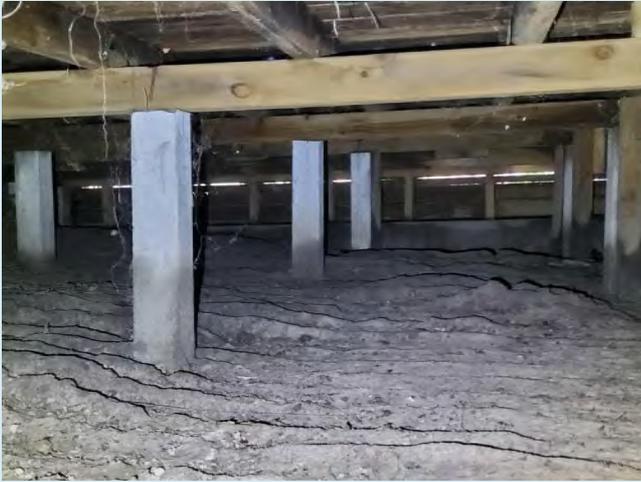
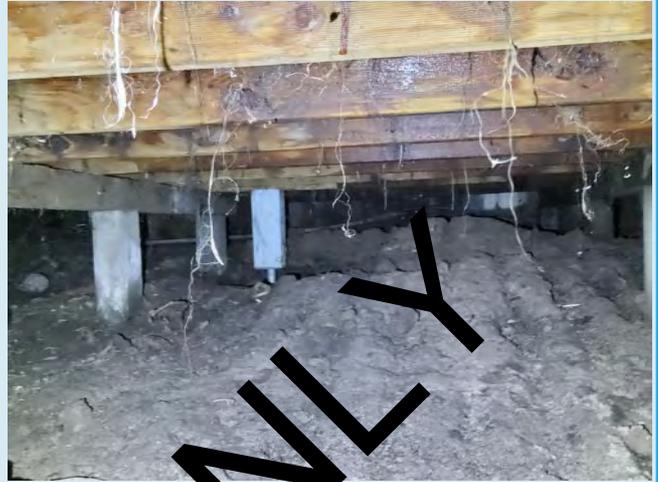
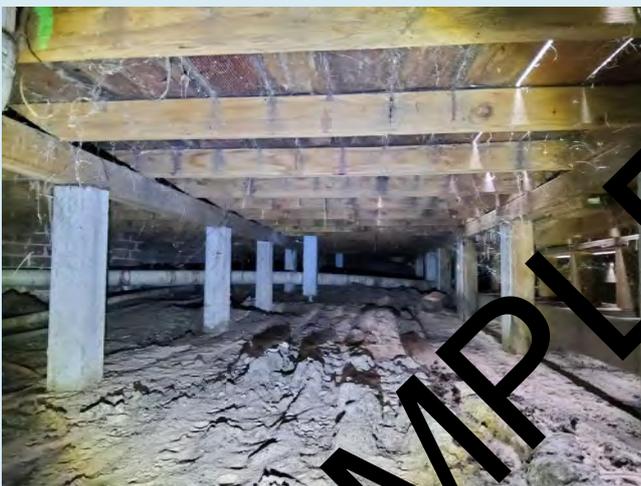
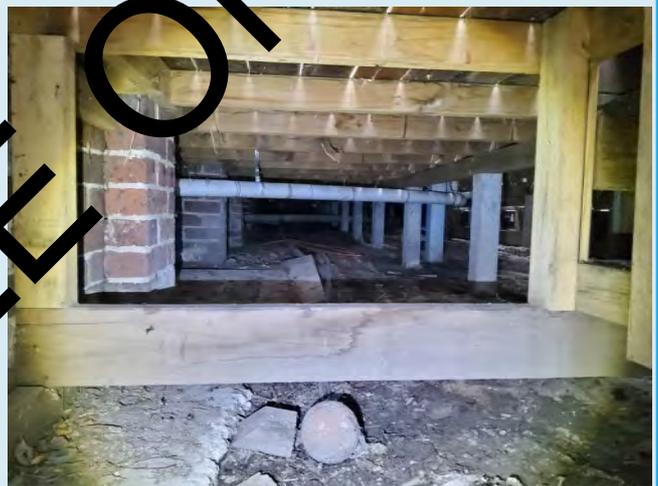
Concrete stumps and timber framing below the deck appeared visually fine where accessible.

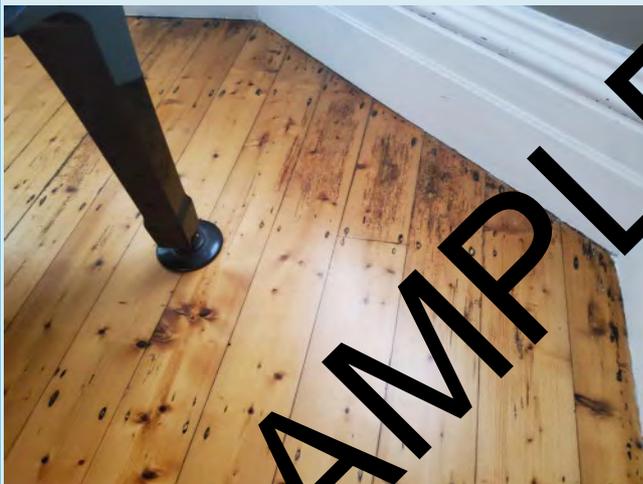
Evidence of Furniture Beetle borer damage (*Anobium* spp.) Was found to floorboards in several areas throughout the house. Some borer emergence holes were found, suggests borers were active. These borers damage timber slowly over a long period of time, but to the point of complete collapse. Recommend a pest control contractor be engaged to advise on treatment options and costs. The most reliable method of control is to replace the borer-damaged timbers and reduce conditions conducive to reinfestation, i.e. maximise subfloor ventilation, minimise damp conditions below the house.

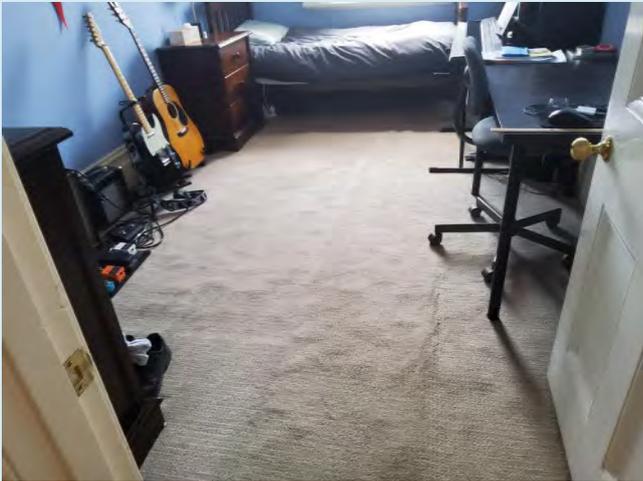
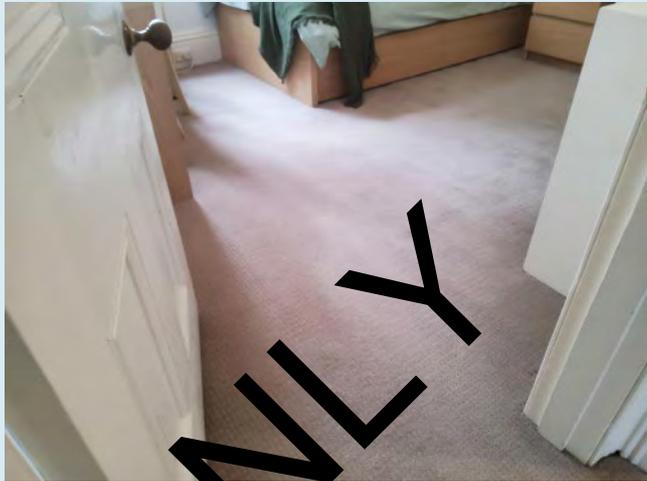
Timber Pest checklist findings	
Unable to Inspect Due to Access	Interior
Comments	
Upper level floor boards in the bedrooms were covered by carpet. As there was borer damage in an upper level bathroom floorboards, further borer damage may be present that was concealed, and may only be revealed when carpets are lifted.

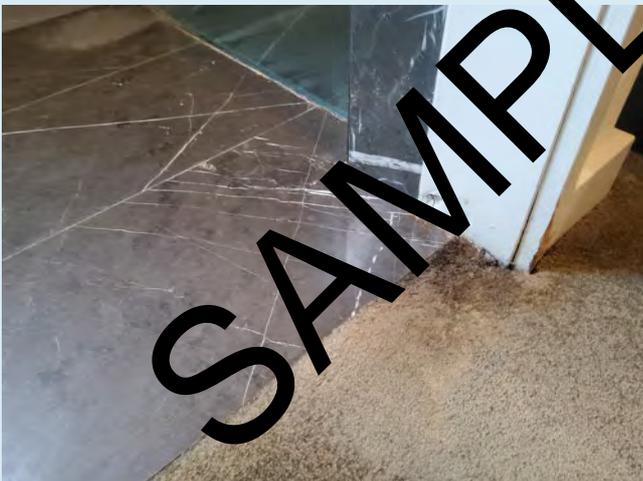
Timber Pest checklist findings	
Activity or Damage Advice on Item	Door Frame
Comments	
Localised heavy fungal decay was found to the base of ensuite door jamb, near the shower recess, due to water seepage from the shower. See ensuite area comments.

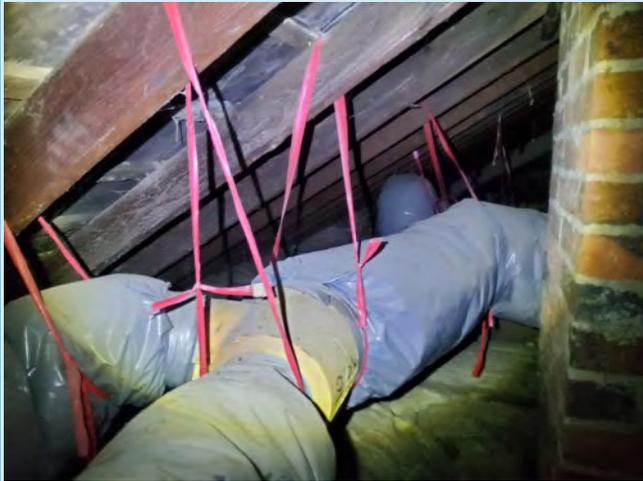
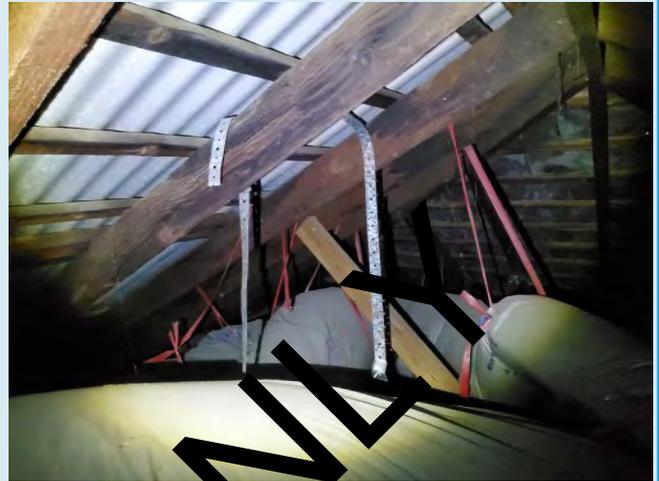
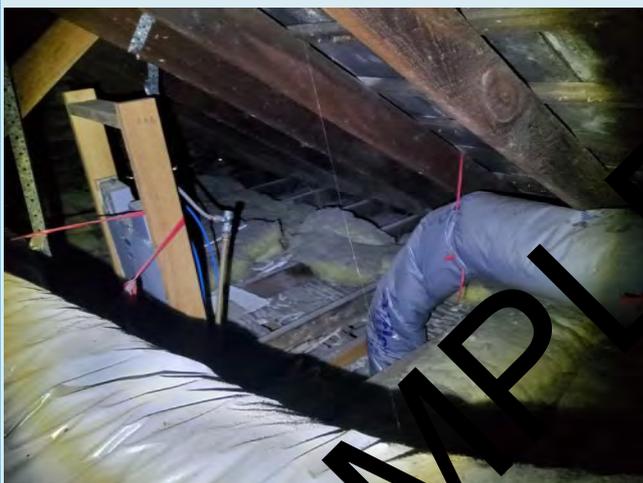
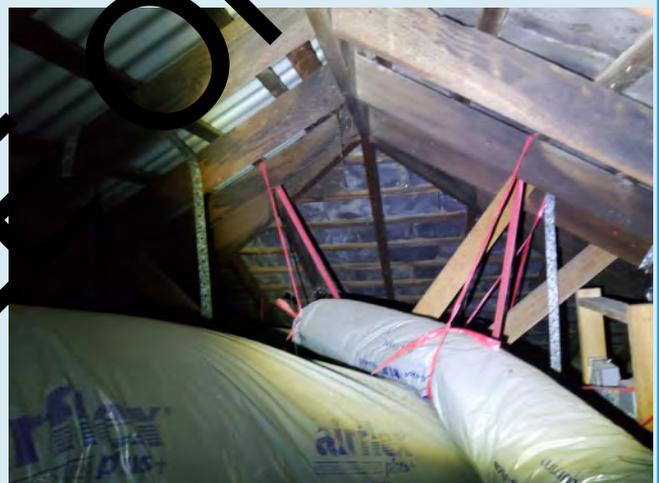
Roof space inspection was limited by low clearance, insulation and ducts. Timber structure appeared fine where visible at the time of inspection.

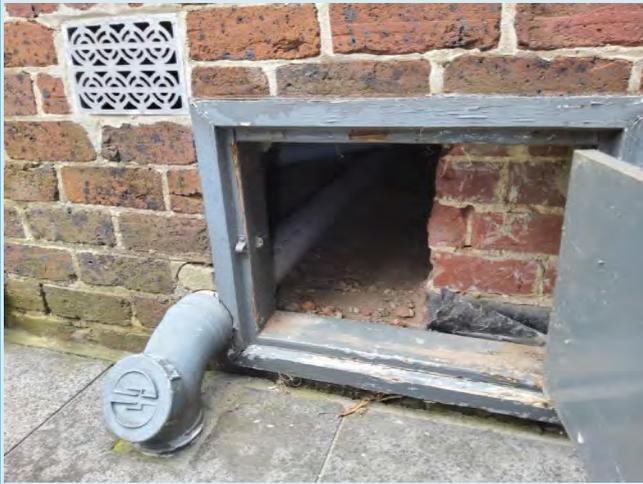
The subfloor area was unable to be inspected due to low clearance and ducts.

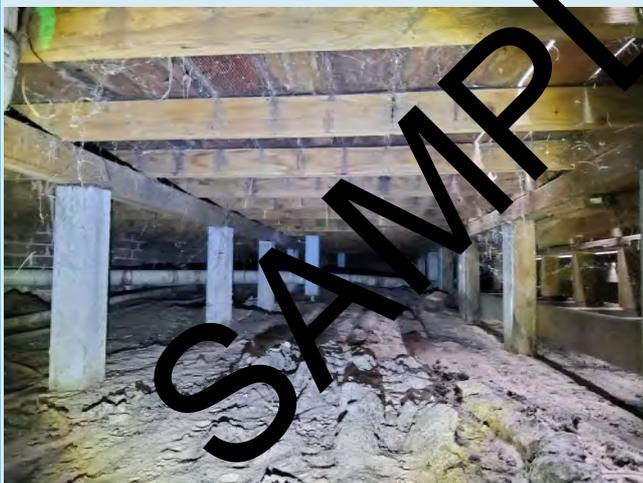
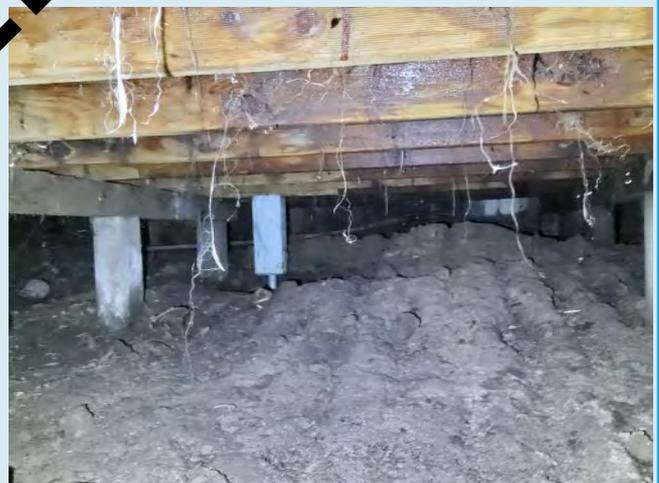
Timber framing below the deck appeared visually fine.

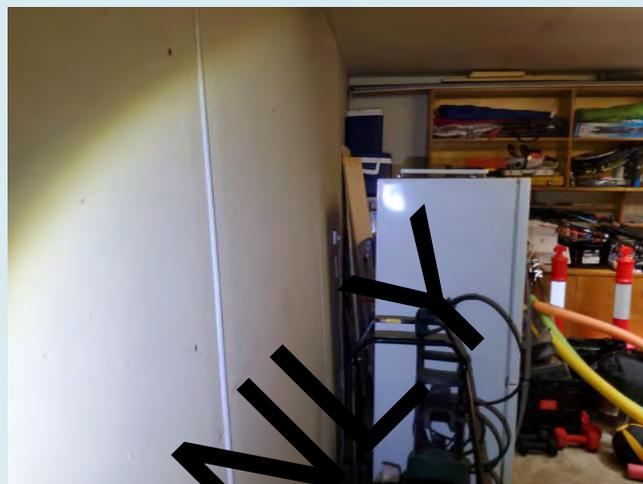
Very heavy fungal decay found to lower timber wall frames visible at the front of the garage. See garage comments in the building section of report.

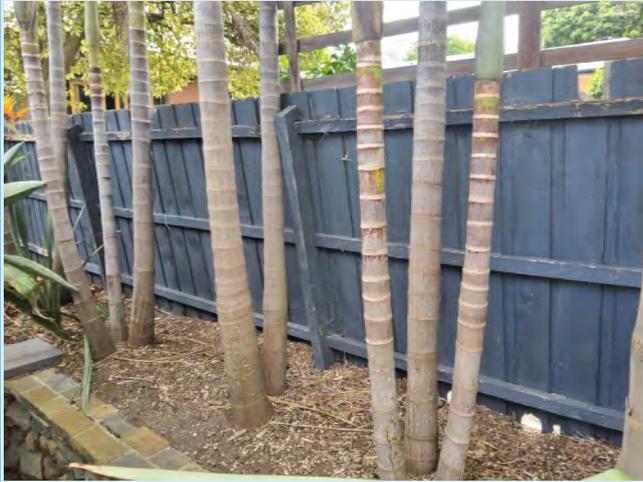
Timber Pest checklist findings	
Activity or Damage Advice on Item	Fence line
<b>Comments</b>	
Heavy fungal decay in places, see the fences comments in building section of the report.

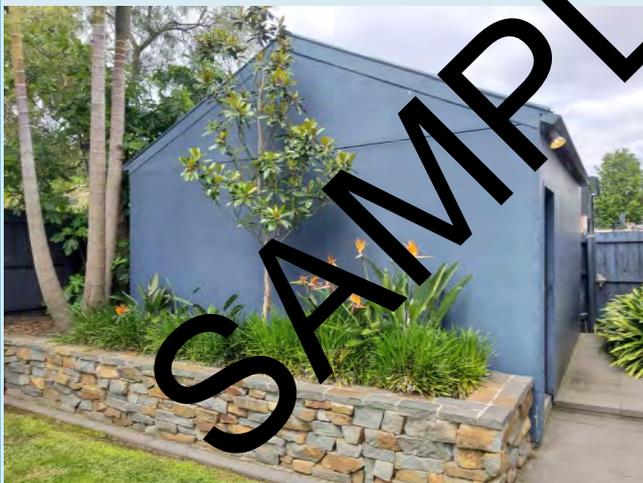
Timber Pest checklist findings	
Action Recommended	Retaining walls
<b>Comments</b>	
Garden beds alongside garage timber walls frames increase the risk of ongoing timber pest infestation. Recommend rebuilding the garage walls with durable materials or removing garden beds.

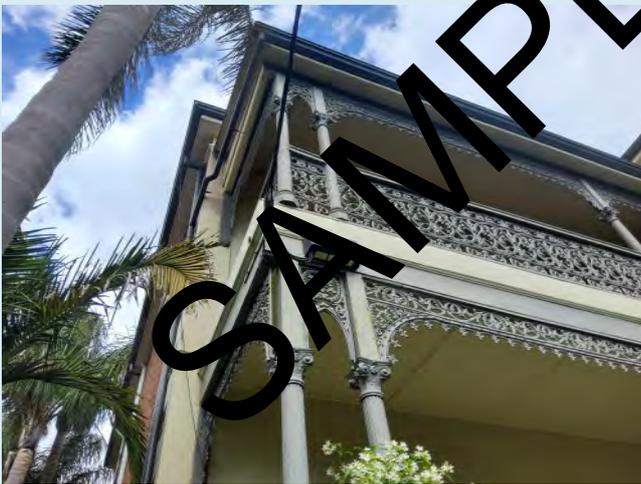
The front verandah beam had heavy fungal decay and evidence of structural movement, which should be rectified as soon as possible. See the building section comments.
